## ECO start/stop inoperative, fault code P0944 in transmission control unit

| Topic number | LI27.57-P-053496 |
| Validity | NAG2 FEPlus (722.9) with auxiliary oil pump with code B03 up to transmission sequence number 7.248.200 |

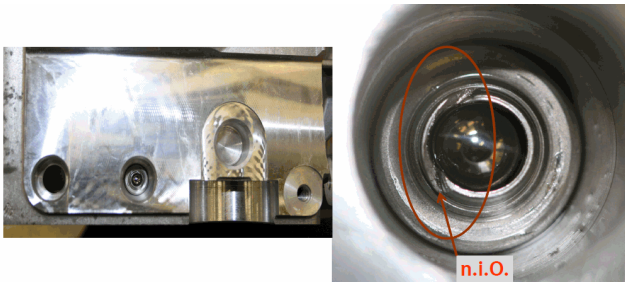
| Attachments | |
|---|---|
| <a href="#">Bild Rückschlagventil im Wandlergehäuse.jpg</a> | Pictures of the valve |

Leakage between torque converter housing and auxiliary oil pump.

Check the check valve in the torque converter housing (in pressure duct) (see pictures in attachment).

If the check valve is n OK, the torque converter housing and the auxiliary oil pump (component M42) must be replaced. When removing/installing the automatic transmission auxiliary oil pump, observe AR 27.30-P-0651EL.
