December 18, 2021

Version 2

## Product Improvement Campaign: 3G TCU VoLTE OTA Update

Year	Model	Trim	VIN Range
2019–21	RDX	ALL	Check the iN VIN status for eligibility.

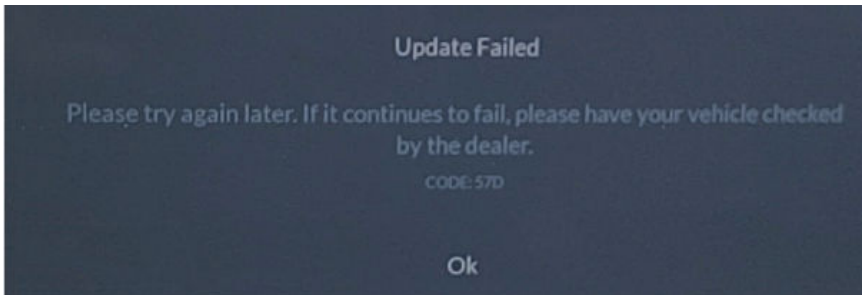
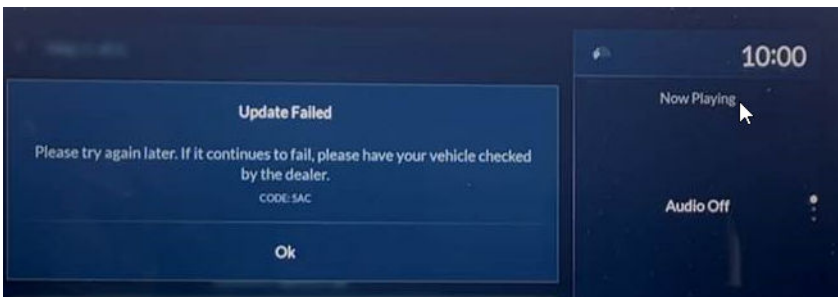
- If you see CODE: 57D or CODE: 5AC, the **Update Failed** due to **Poor cellular signal**.

- Move the vehicle to an open-air area to get **Optimal Cellular Signal** strength.

- Go back to step 1 to start the process once again

**NOTE: If repeated system Update Failed messages appear, refer to the troubleshooting procedure in the service information and do diagnostics for possible TCU hardware failure.**
