60-19-04 - Sunroof Water Leak - Reduced Adhesion Causing Loose Seal (U.S. Only)

Release date: 12/1/2021

Applicable Vehicles					
Model(s)	Year	Eng. Code	Trans. Code	VIN Range From	VIN Range To
Tiguan LWB	2018-2022	All	All	AX_JM000001	AX_NM019254

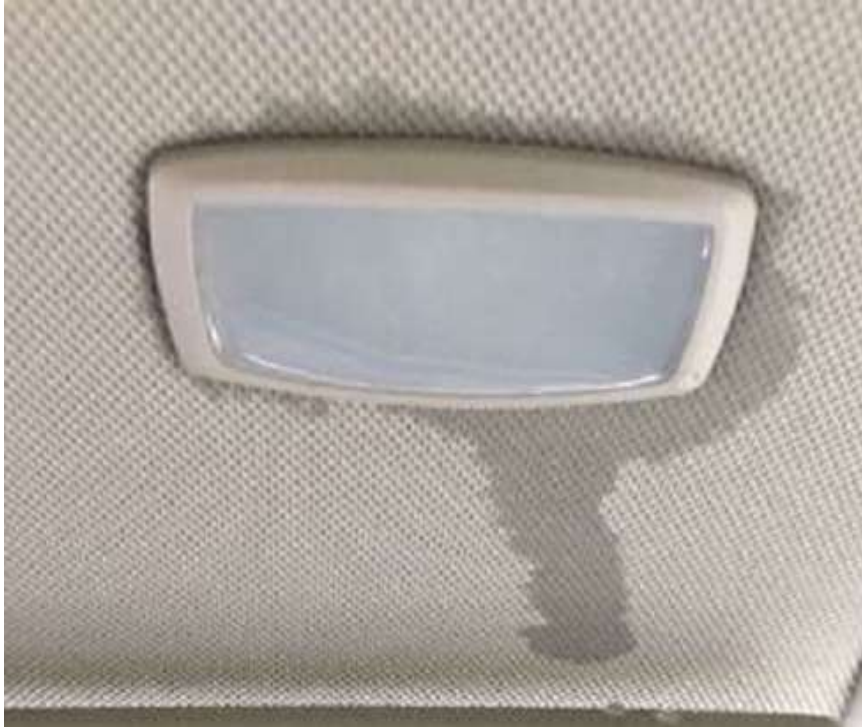
Front headliner area is wet around the vanity light(s), sunroof, and overhead console area due to water entering via the sunroof.

Figure 1: Example of water leak coming from the front vanity light.

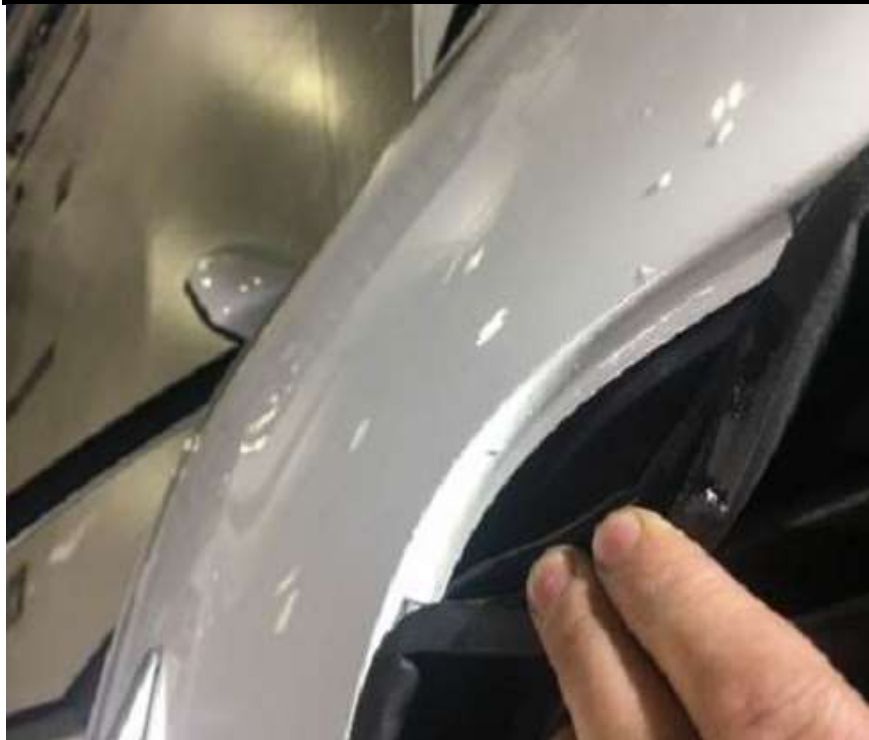
Water leak is due to poor adhesion of the sunroof body side seal to the body.

Figure 2: Example of the sunroof body side seal not having proper adhesion to the body.

- Remove the sunroof frame per ELSA repair instructions, “Body -> Body Exterior -> 60 Sunroof -> Sliding Sunroof -> Sunroof Frame, Removing and Installing” in Elsa.
- Remove the sunroof body side seal per ELSA repair instructions, “Body -> Body Exterior -> 60 Sunroof -> Sliding Sunroof -> Sunroof Seals, Removing and Installing -> Outer seal, Removing and Installing” in Elsa.

Start by pulling slightly on the body side seal and moving along the seal to confirm proper adhesion of the seal to the body until the seal is completely off. Once the seal has been removed, inspect it for non-adhered sections.

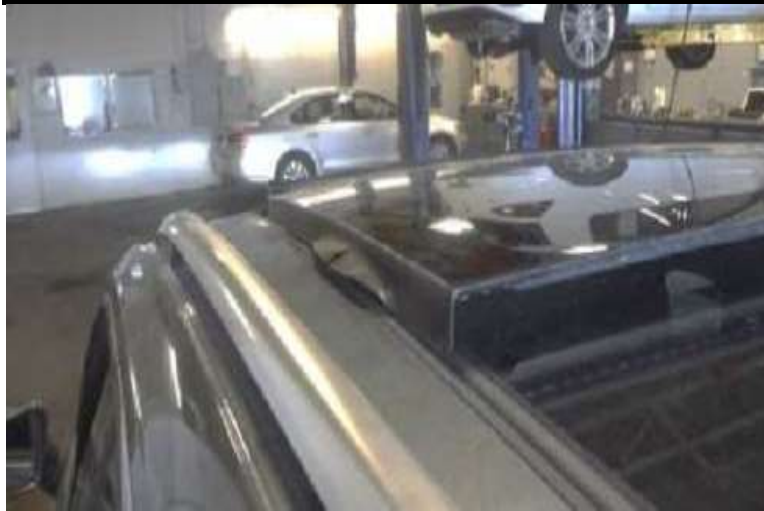
Figure 3: Example of the sunroof panel molded seal warped/deformation.

- Visually ensure sunroof panel molded seal and body side seal have no deformation.

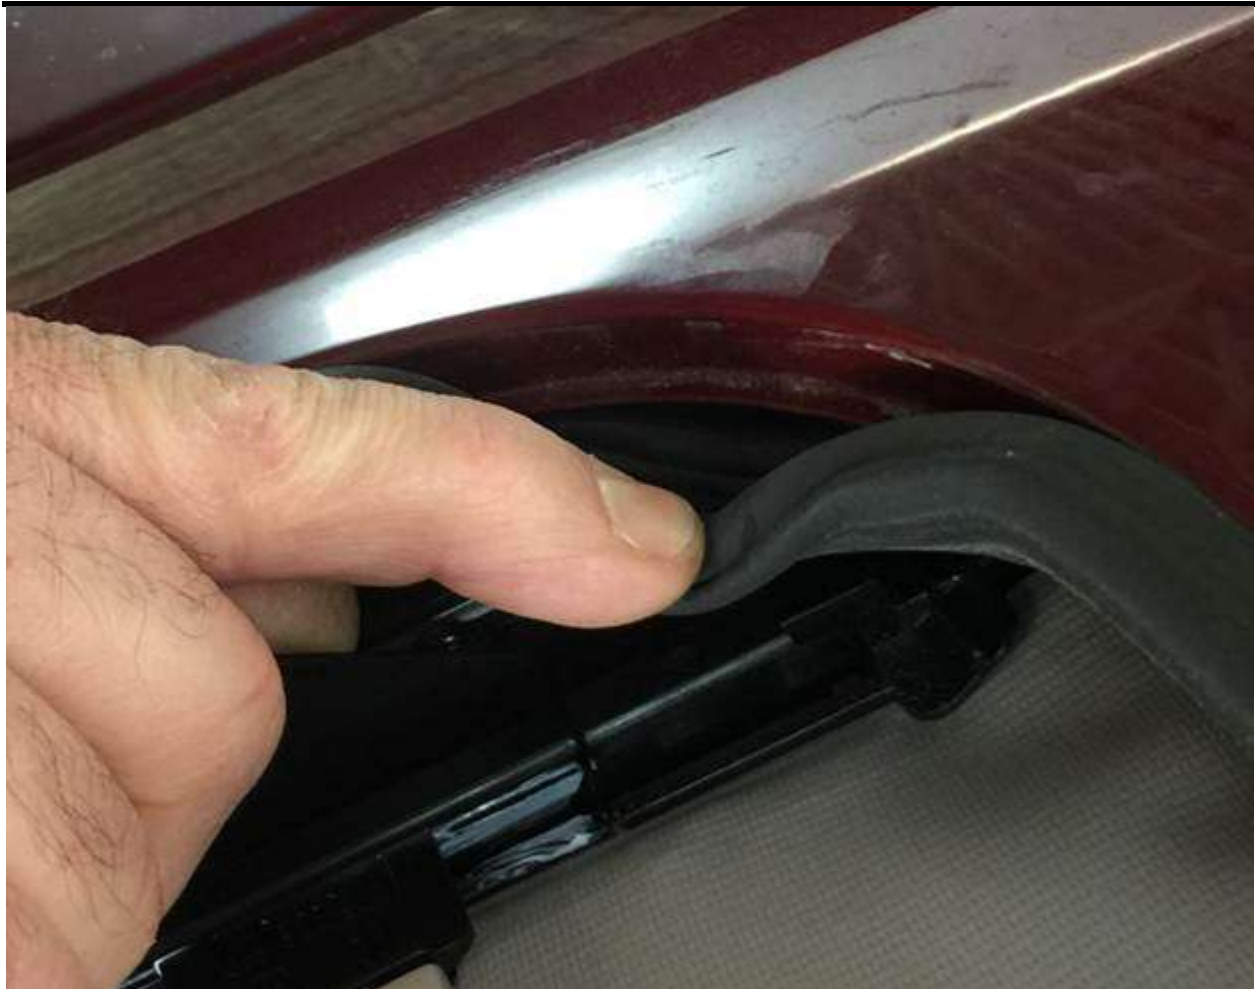
Figure 4: Example of a adhesion issue photo for uploading into WISE.

Take photos of the seal and body sections that were not adhered to the body and upload to WISE for a valid warranty claim.

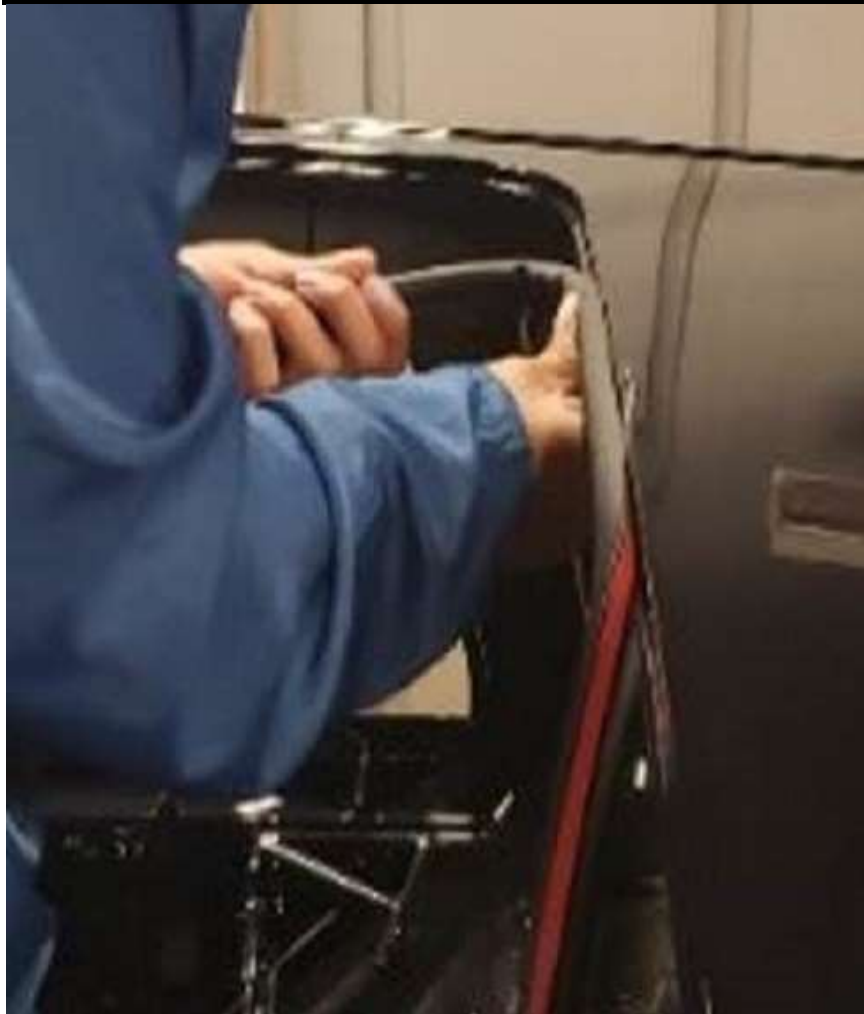
Figure 5: Example of installing the body side seal WITHOUT removing the “red” protective tape.

During the initial installation process DO NOT remove the “red” protective tape on the seal. Remove the “red” protective tape ONLY after the seal has been properly seated (Figure 5).
