TECHNICAL SERVICE BULLETIN

2.3L EcoBoost - Illuminated MIL With DTC P04F0 And/Or P144C

21-2446
16 December
2021

Ford 2020-2022 Explorer	Engine: 2.3L EcoBoost
----------------------------	-----------------------

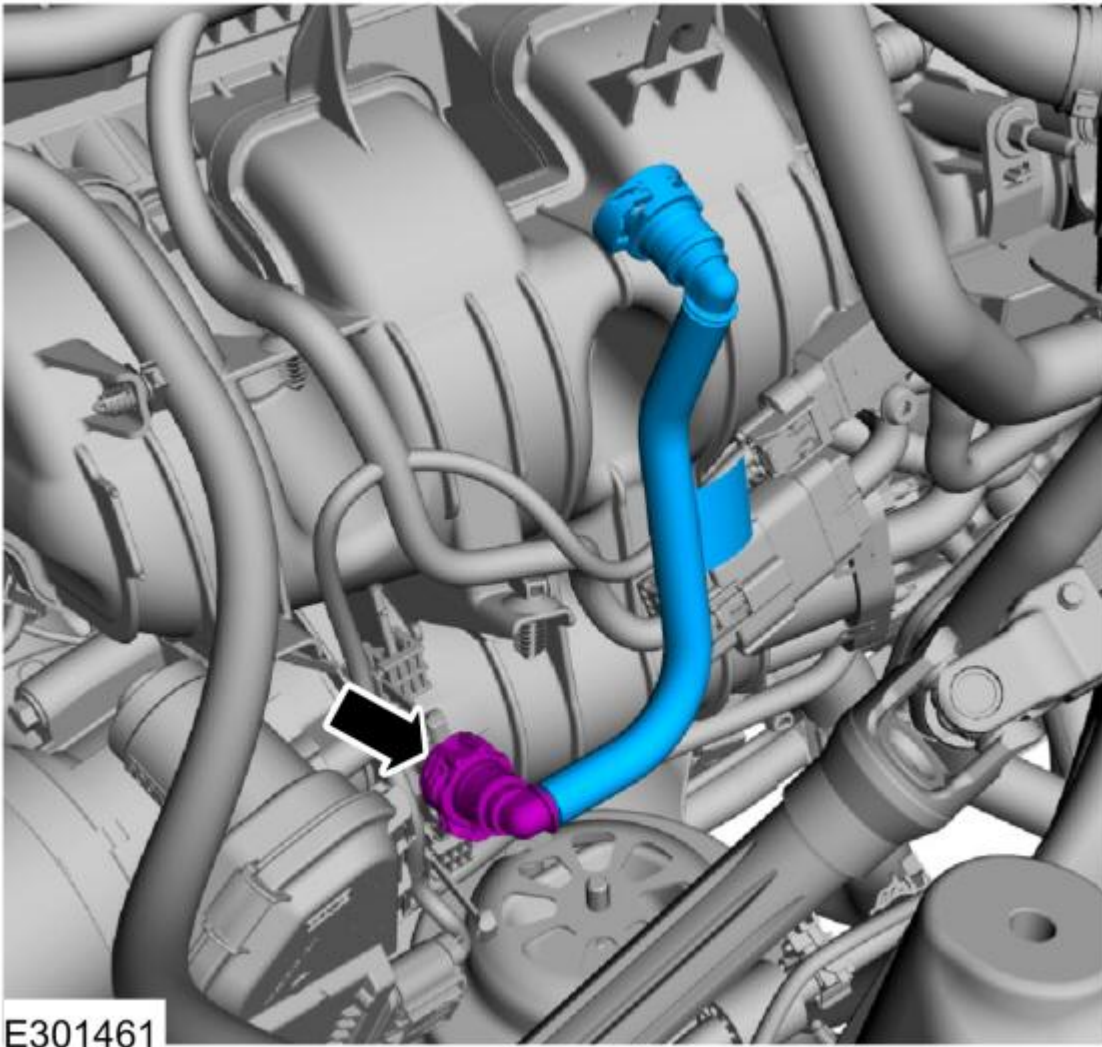
Figure 1

1. Visually inspect and push and pull on each of the following EVAP connections to verify a proper connection:
 - (1). Vacuum port side and pressure port side of the ejector. (Figure 1)

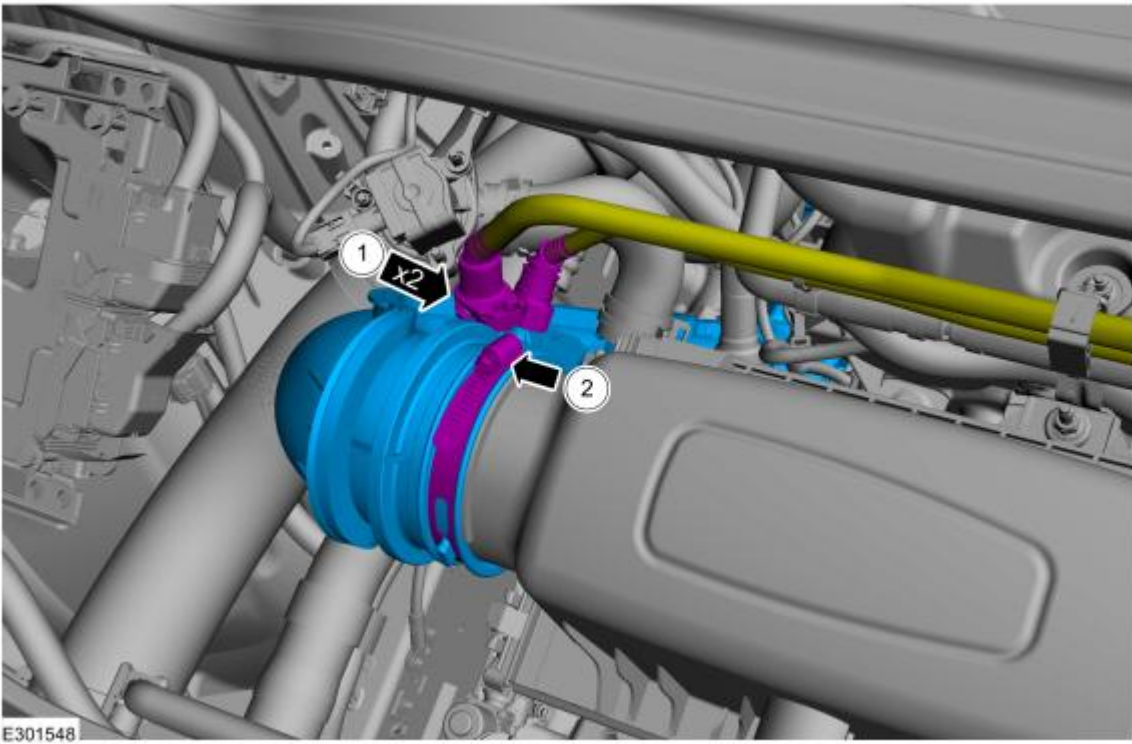
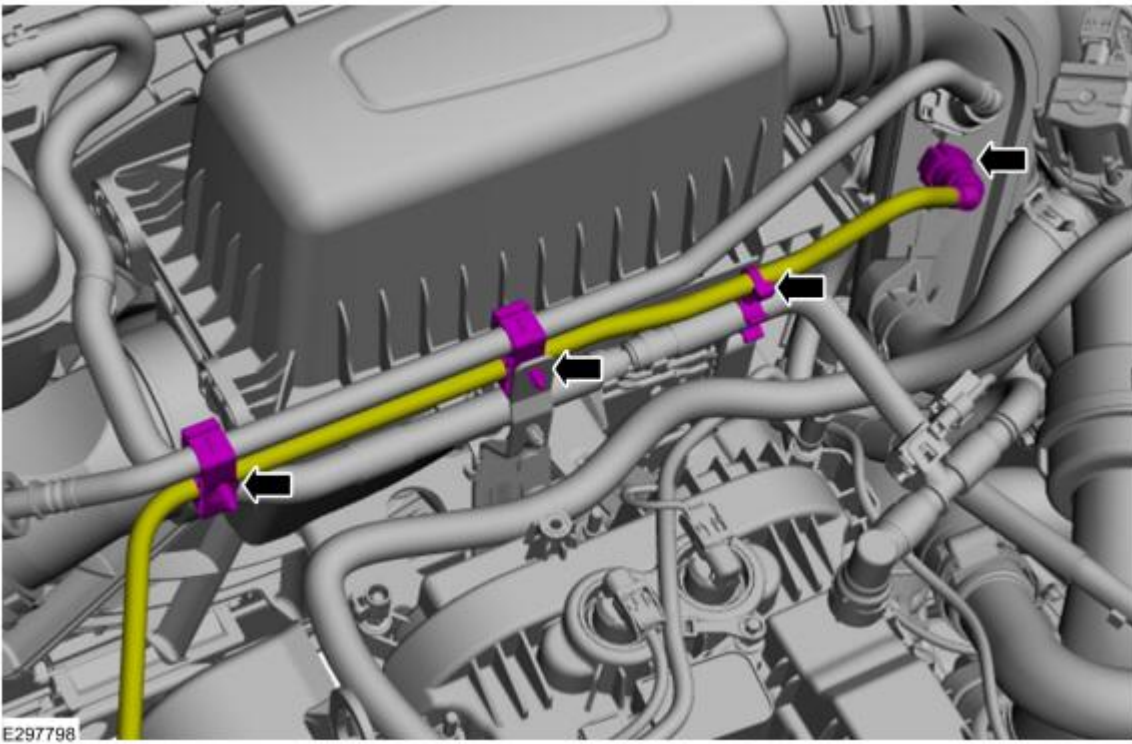
(2). Port on the air intake system (AIS) duct at throttle body inlet. (Figure 2-3)

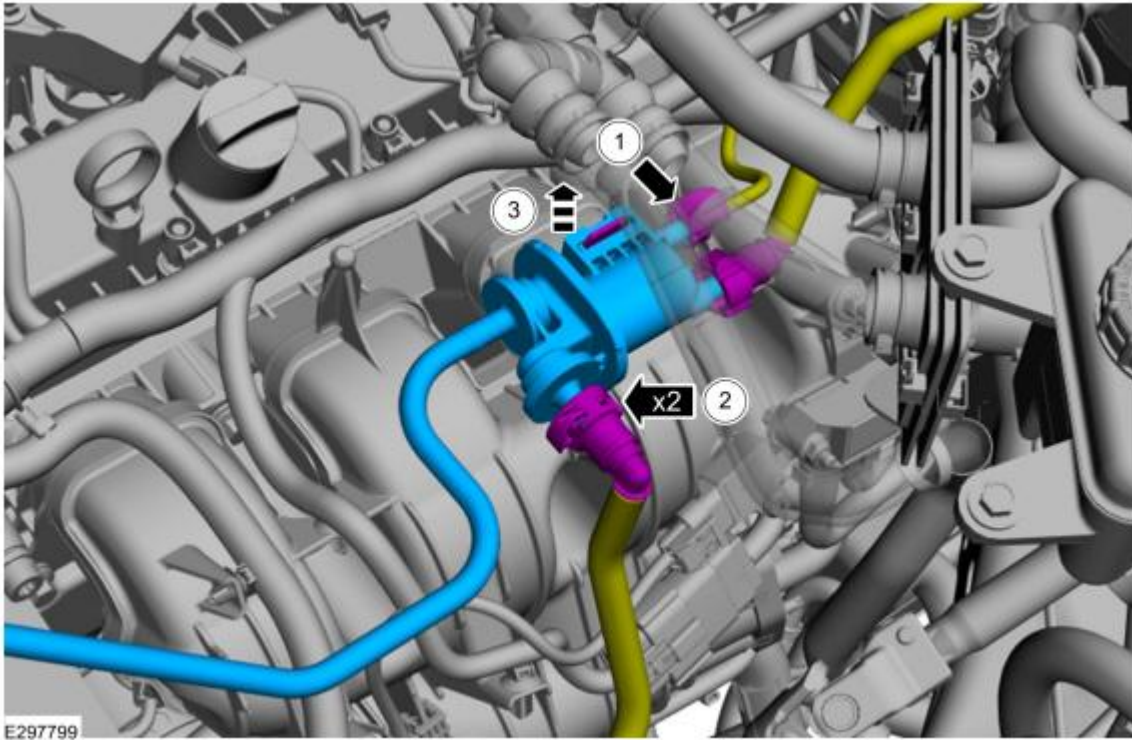
Figure 4

(3). Vacuum side of the purge valve (side port on the purge valve). (Figure 4)
