## Service Bulletin

Bulletin No.: 20-NA-136

Subject: Diagnostic Tips for DTCs Set at a Low Mileage for 9T65 Transmissions

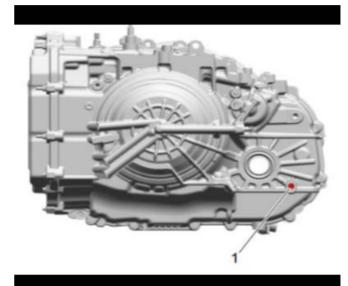
5619626

- 6. While the vehicle is idling, remove the oil level set plug (1). Allow any fluid to drain:
  - If the fluid is flowing as a steady stream, wait until the fluid begins to drip.
  - If no fluid comes out, add fluid until fluid drips out.
- Record fluid level; overfilled, under-filled, correct on repair order and how much was needed to fill or came out:
  - If fluid is overfilled, set correct level and retest.
  - If fluid is under-filled, inspect for external leaks. Refer to Fluid Leak Diagnosis.
- 8. If fluid level is correct, then check condition of the fluid.

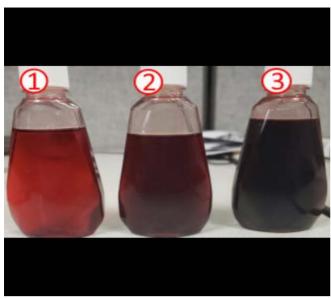
5840393

- 8.1. Inspect the fluid color.
  - The fluid should be red or dark brown.
  - It should be transparent so that objects or writing can be seen through it. Sample #1 is an example of acceptable fluid. Sample #2 is an example of very dark fluid. Sample #3 is an example of black fluid.

- In addition to checking the fluid color and transparency, the fluid should be checked for an odor of burnt fluid. If the fluid is very dark, black, or has a burnt odor it would indicate clutch damage has occurred internally in the transmission and it would need to be removed from the vehicle and investigated.
