## Subject: Radio Software Version V808 USB Update

*This bulletin replaces PIC6410A. Please discard all previous copies of PIC6410A.*

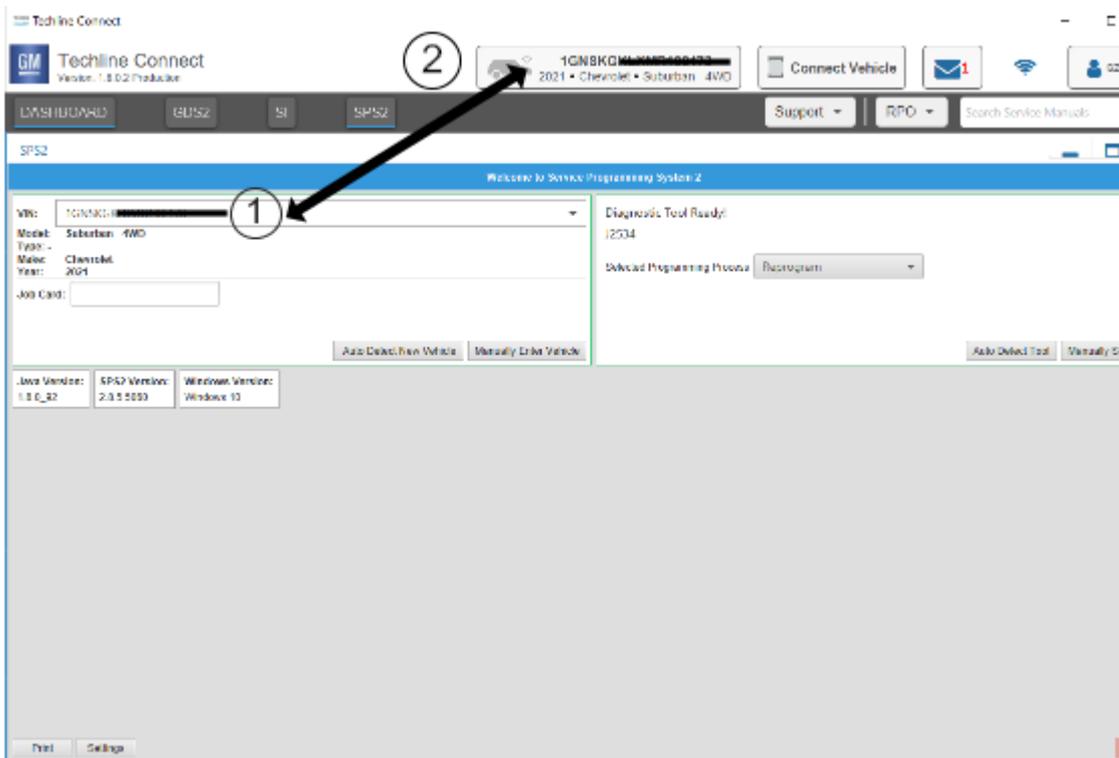
5743643

**Caution:** Be sure the VIN selected in the drop down menu (1) is the same as the vehicle connected (2) before beginning programming.

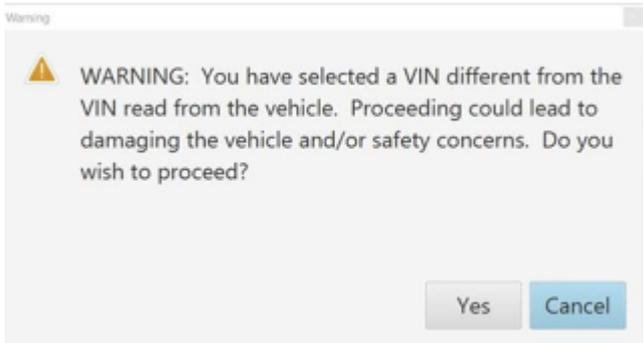
5877000

**Important:** If the vehicle VIN DOES NOT match, the message below will be shown.

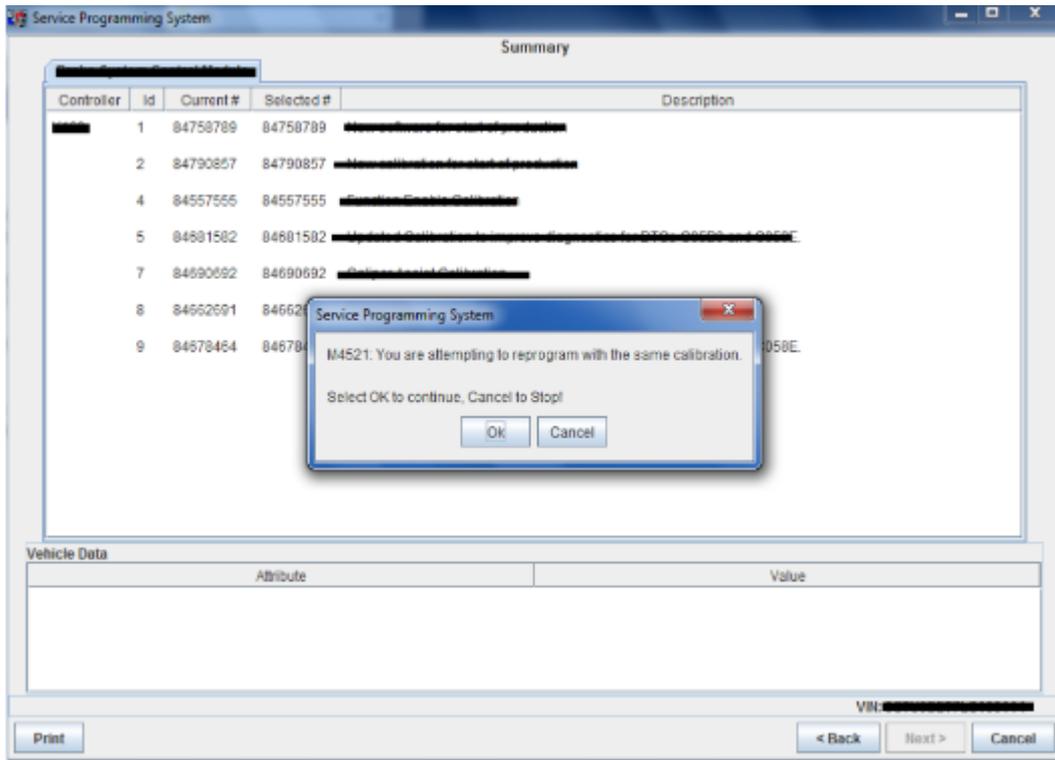
5431207

**Important:** If the Same Calibration/Software Warning is noted on the TLC or SPS Summary screen, select OK and follow on-screen instructions. The system will generate a warranty claim code (WCC) for documentation purposes only. Perform service information (SI) diagnostics to determine the cause of the condition. Use the applicable labor operation code when submitting a warranty claim. Do NOT use the WCC with the warranty claim submission.

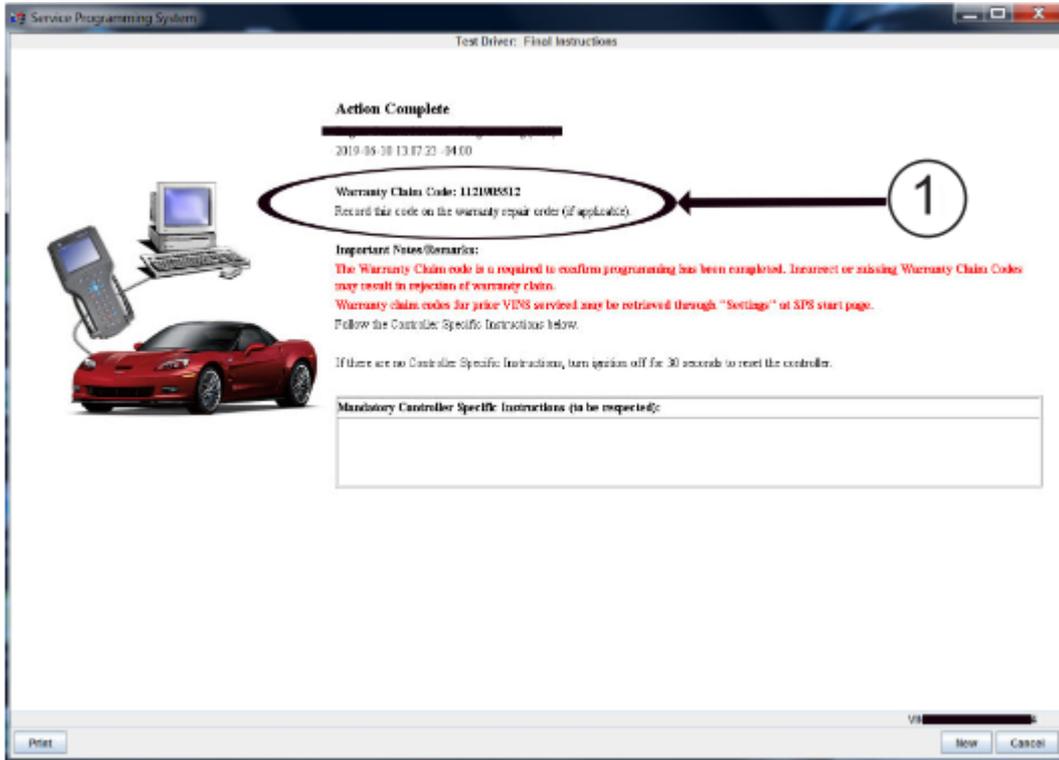
5431209

**Important:** To avoid warranty transaction rejections, you **MUST** record the warranty claim code provided on the SPS Warranty Claim Code (WCC) screen shown above on the job card. Refer to callout 1 above for the location of the WCC on the SPS screen.

- Record the SPS Warranty Claim Code on the job card for warranty transaction submission.
