# Service Bulletin

Bulletin No.: 21-NA-149

**Subject: Engine Wire Harness Chafing / IPC Gauges Sweep / IPC Warning Message / SES/Check Engine/MIL / No Start / No Crank / Runs Rough / Stalls / Reduced Engine Power / Various DTCs**

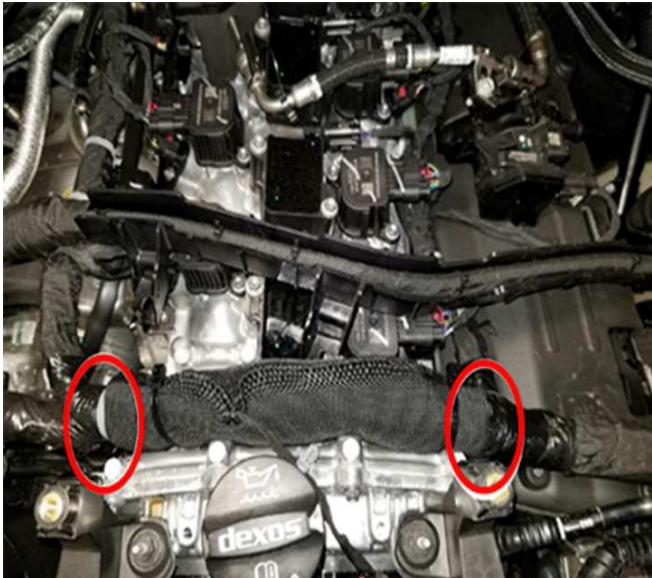
<p style="text-align: right;">5394681</p> <p>Example of engine wiring harness damage at Camshaft Carrier Cover shown below.</p>

<p><b>Cause 1</b></p>	<p><b>This Cause pertains to vehicles equipped with engine 2.7L, L3B only.</b></p> <p>These concerns may be caused by engine harness contact with under hood components.</p> <p><b>Caution:</b> This Document Only Applies To VINs NOT Covered by Customer Satisfaction Program N192219370 Please Verify In VIS Before Proceeding</p> <p>Shown below are areas that should be inspected for this concern.</p> <p>Inspect the engine harness as it crosses over top of the Camshaft Carrier Cover. Harness damage can occur at any point across the Camshaft Carrier Cover. Typical inspection locations shown below.</p>

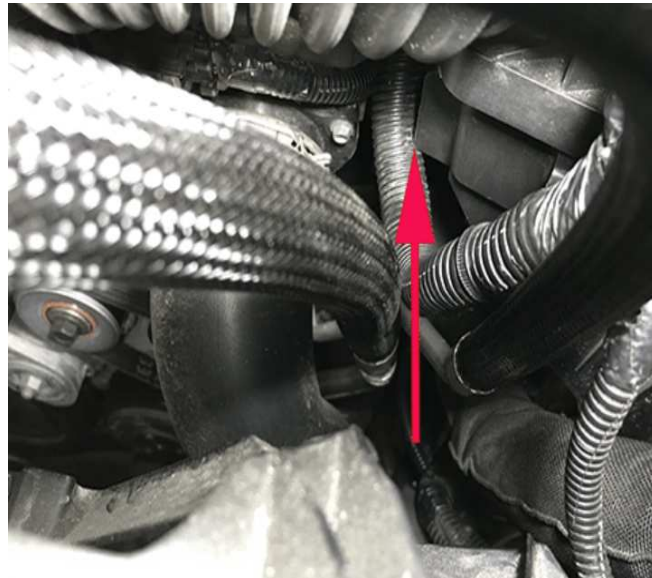
5394683

Inspect the engine harness at the Lower Air Cleaner Housing as shown below.

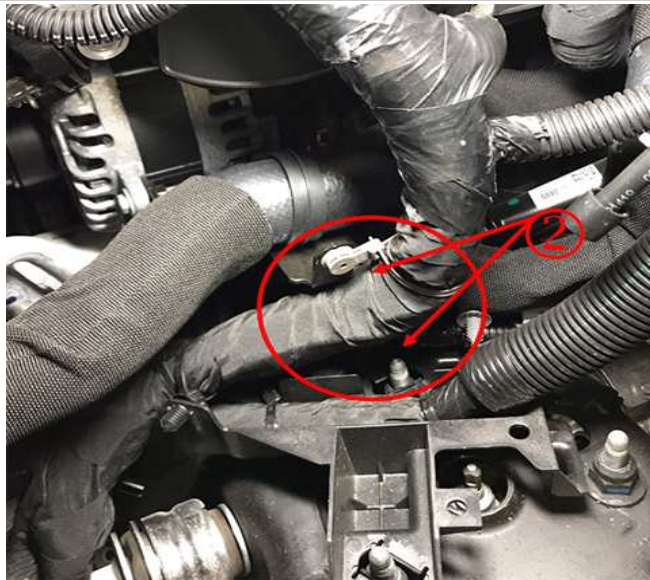
5324752

Example of engine harness damage, Lower Air Cleaner Housing removed shown below. Inspect the engine harness at the Generator Bracket and Left Front Coil Spring stud as shown below.

**Note:** Under normal driving conditions, the engine will rock back and forth in its mounts.

This may result in harness contact with this bracket that may not be present during engine off inspections.

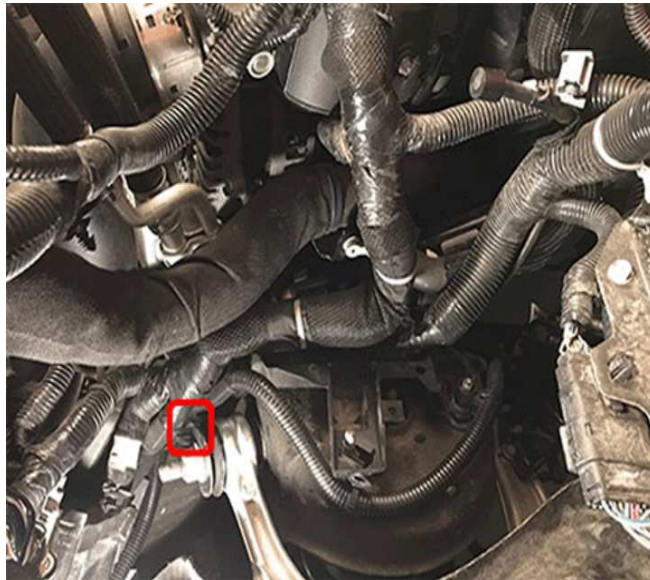
5394677

Inspect the engine harness at the Left Front Upper Control Arm Bushing as shown below.

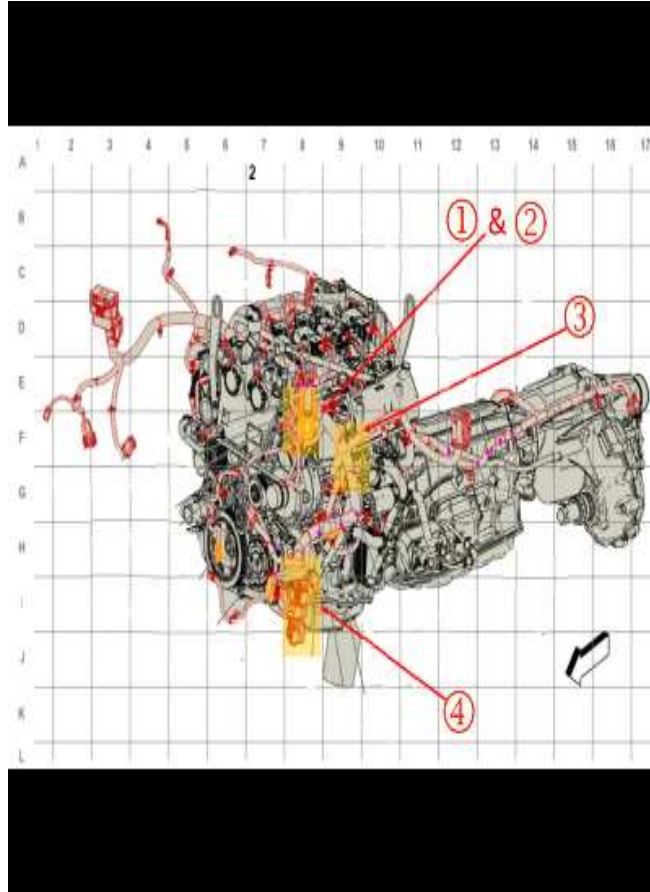
5911724

These concerns could be caused by engine wiring harness chafe on underhood components at various locations:

- Front corner of the left hand cylinder head (1)
- Drive belt idler pulley bracket (2)
- Oil Dipstick bracket (3)
- ECM/TCM bracket (4)

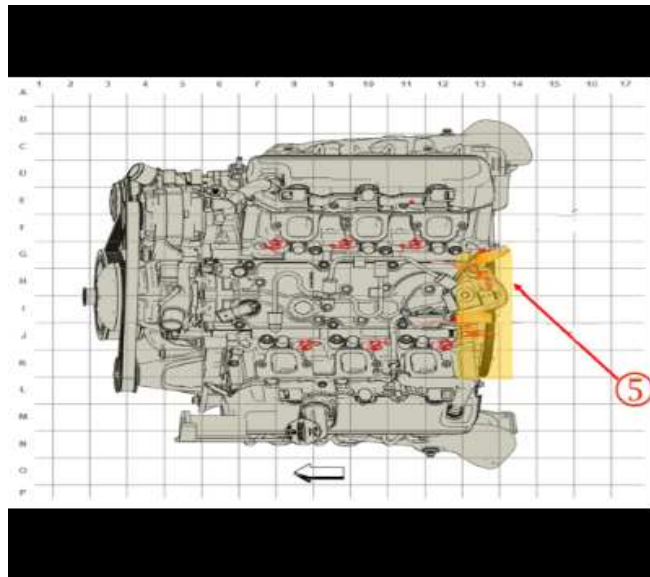
5911725

- Fuel Rail (5)

<p>This harness chaffing could cause shorting of any number of circuits to ground. Due to the number of circuits in the harness, there is a wide variety of different symptoms that could occur depending on which circuit(s) are damaged.</p>
<p><b>Cause 3</b></p>	<p><b>This Cause pertains to vehicles equipped with engine 3.0L, LM2 only.</b>  <u>For any of the DTC's listed above inspect the following areas</u></p> <ol style="list-style-type: none"> <li>1. The engine harness pinched/shorted/chaffed at grid coordinates G-8, as shown below. This location is approximately 18 inches from the ECM connectors (1) and on top of the generator (2), as shown below. Due to the number of circuits in the harness, there is a wide variety of different symptoms that could occur, depending on which circuit(s) are damaged.</li> <li>2. The engine harness shorted/chaffed at grid coordinates C-9, as shown below. The engine harness could be shorted out on the PVC hose clamp at the crankcase pressure regulator, as shown below (6). This is located approximately 4 inches from the crankcase sensor connector pigtail harness breakout.</li> </ol> <p><u>For DTC's: P0201, P0202, P0203, P0204, P0205, P0206, and/or P0216 inspect the following 3 areas:</u></p> <ol style="list-style-type: none"> <li>1. Inspect for poor terminal tension at connector X160, shown below as callout 25. While inspecting X160 make sure the terminal locking feature (4) is not missing.</li> <li>2. Inspect the fuel injector connectors to make sure they are fully connected/seated.</li> <li>3. Inspect the fuel injector wiring harness near the X160 connector (3) for being pinched/shorted/chaffed, as shown below (5).</li> </ol> <p><u>For DTC's: P2382,P2383,P11CC,P11D5,P1488,P14D9, and/or P23AF inspect the following area:</u></p> <p><b>Note:</b></p> <ol style="list-style-type: none"> <li>1. Inspect the exhaust pressure differential sensor harness at the connector. The circuits may appear good, and test within a proper reading.</li> <li>2. Gently pull on the individual wires. This will sometimes cause 1 or 2 wires to break at the connector.</li> <li>3. After installing the new connector, we advise adding extra tape to limit the movement/vibration of the harness at the connector.</li> </ol>

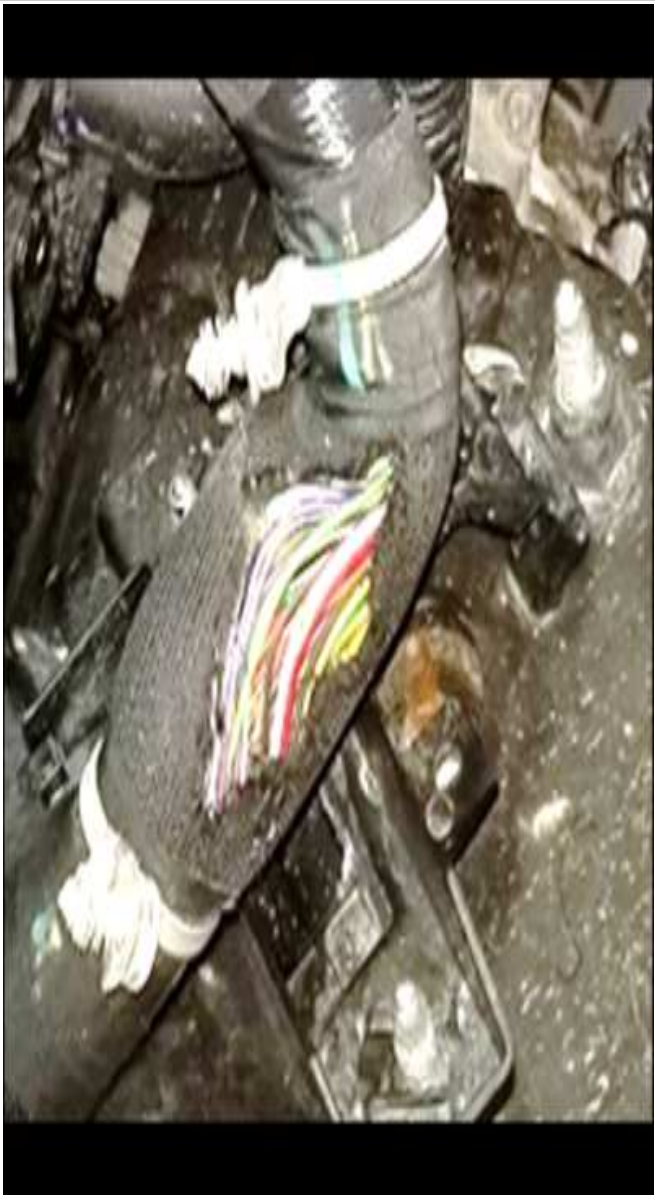
5868347

Examples of extreme wire chaffing.

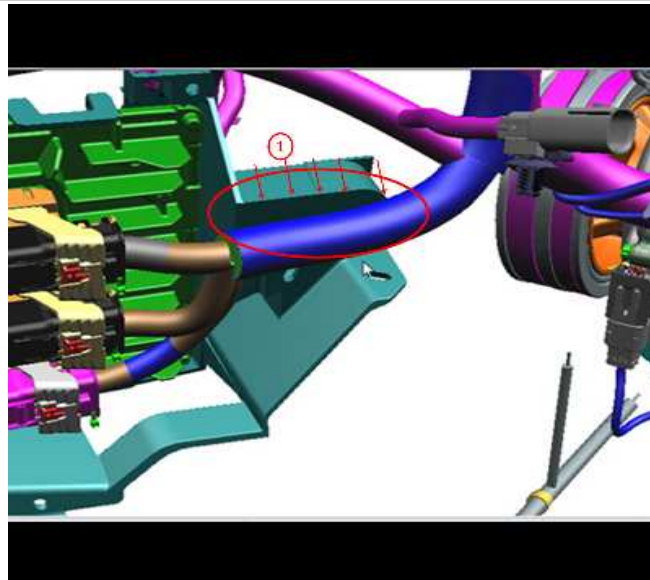
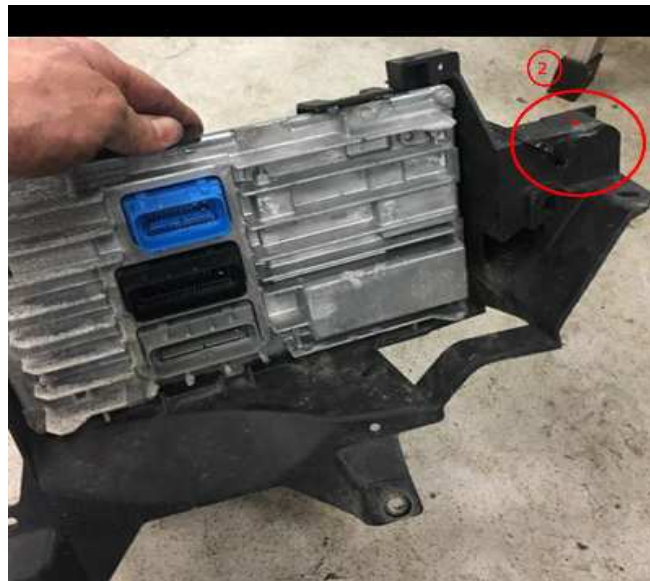
The cause of the condition may be an engine wire harness clip was removed during production due to ergonomic issues (hand clearance and branch stiffness). This led to an uncontrolled branch that came into contact with a sharp edge (1) & (2) on the ECM/TCM bracket, driver side upper control arm, and/or shock tower and caused chaffing during engine vibration and roll.

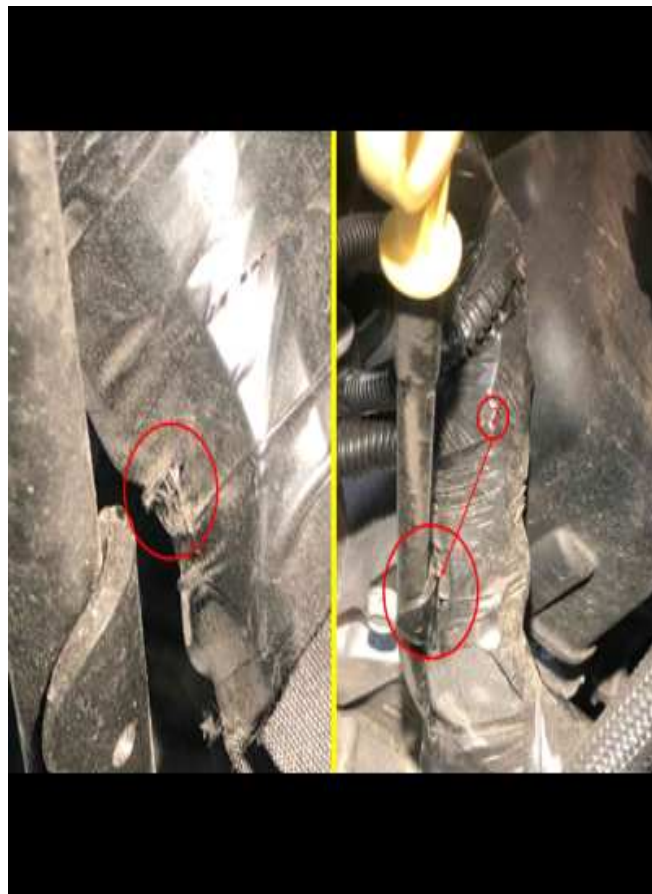
5911722

**This Correction pertains to vehicles equipped with engine 4.3L, LV3 only.**  
**Note:** The first graphic below is a before, and after (2), repair example of harness chaffing at the Oil Dipstick bracket.

To correct this concern, repair the damaged wiring following the SI wire-to-wire repair procedures. Once repaired, protect and reposition the engine wiring harness to prevent future harness damage.

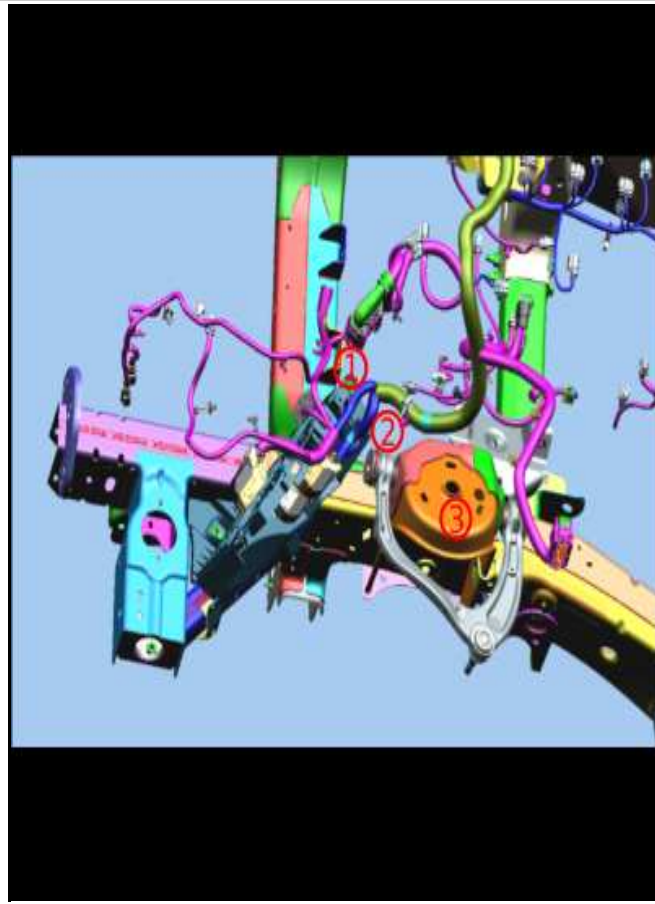
5868341

3. Locate the three contact points where the wire harness is chaffing, the ECM/TCM black bracket (1), the upper control arm (2), and the shock tower bolt (3).

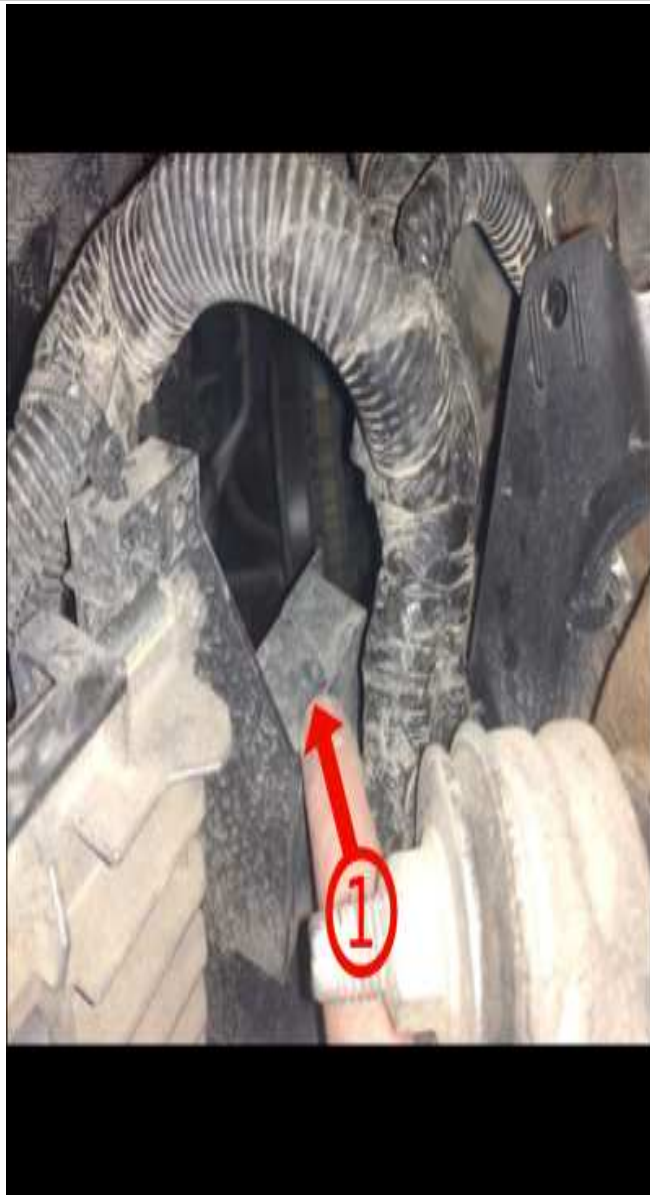
5868349

4. At the ECM/TCM bracket, locate the wire harness laying against the ledge (1).
