## **Service Bulletin**

Bulletin No.: 21-NA-197

Subject: Power to the 110V/120 Outlet is Interrupted During an Auto Stop/Start Event (United

States ONLY)

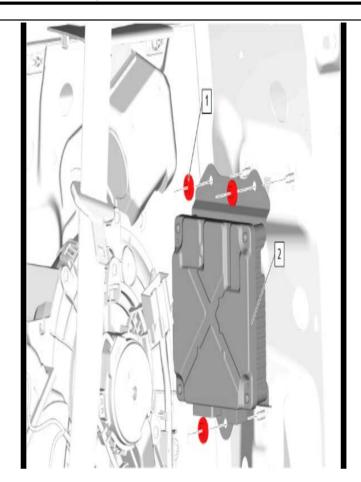
5569856

Involved Region or Country	United States, Canada	
Additional Options (RPOs)	Without 9C1 (SALES PACKAGE-POLICE VEHICLE), Equipped with ENTERTAINMENT PKG-RR SEAT, DUAL DISPLAY, SEAT BACK (UW9)	
Condition	Some customers may comment the 110/120 volt power outlets are inoperative during an Auto Stop/Start event. The 110 VAC outlet may have experienced a power interruption during the start of the vehicle.	
Cause	The cause of this condition may be a concern within the T1 DC/AC Converter Control Module.

Replace the Accessory AC and DC Power Control Module (2). The new module has hardware and software modifications to maintain limited operation during Auto-Start events.

Refer to Accessory AC and DC Power Control Module Replacement, in SI.
