# Service Bulletin

Bulletin No.: 21-NA-229

**Subject: Poor Engine Performance in Extremely Cold Weather Conditions for LSY Engines, Charge Air Cooler Icing, Malfunction Indicator Lamp (MIL) Illuminated**

Brand:	Model:	Model Year:		VIN:		Engine:	Transmission:
		from	to	from	to		
Cadillac	XT4	2019	2021	—	—	2.0L Turbo (LSY)	—

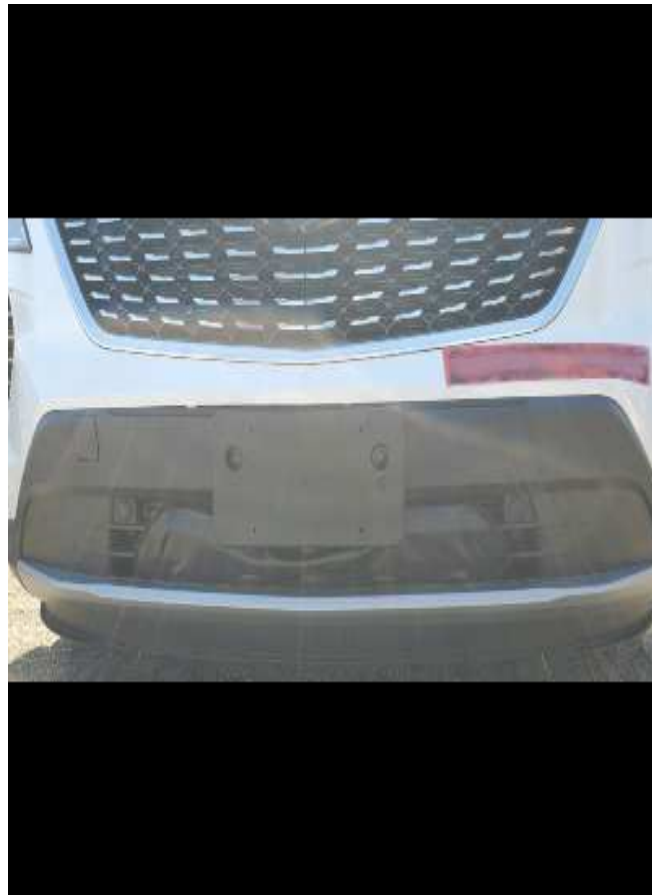
5909887

<b>Involved Region or Country</b>	North America
<b>Condition</b>	Some customers may comment on one or more of the following conditions when driving in extremely cold weather conditions (-18°C or less / 0°F or less): <ul style="list-style-type: none"><li>• Loss of power</li><li>• Hesitation on acceleration</li><li>• Stalling condition</li><li>• MIL Illuminated</li></ul>
<b>Cause</b>	This condition may be caused by ice accumulation in the charge air cooler (CAC), restricting air flow.

A winter grille cover has been released to address this issue. Instructions for installation are included with the grille cover. The cover can be installed by the technician initially but the technician needs to educate the customer on the removal process after the winter season ends and how the customer will reinstall the cover the following winter season. One time installation of the winter grille cover is covered under warranty. This can be installed and charged to the unique labor operation code provided in this bulletin.

**Important:** *The winter grille cover should be installed in extreme cold weather and removed when the winter season changes.*

**Note:** *Clean the surface before installing the winter grille cover.*
