Subject: Short Range Radar (SRR) with DTC U3000 49 Set

Brand:	Model:	Model Year:		VIN:		En- gine:	Transmis- sion:
		from	to	from	to		
Cadillac	Escalade Escalade ESV	2021	2021				
Chevro- let	Suburban Tahoe	2021	2021				
GMC	Yukon Yukon XL	2021	2021

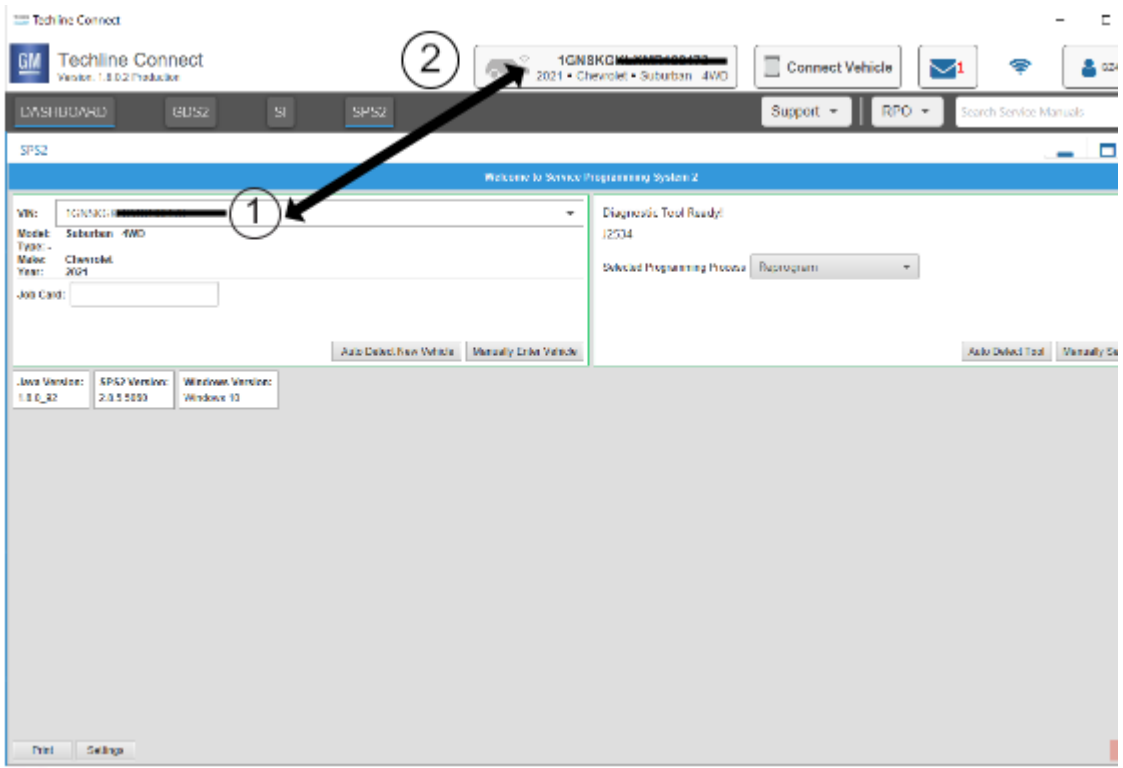
5743643

Caution: Be sure the VIN selected in the drop down menu (1) is the same as the vehicle connected (2) before beginning programming.

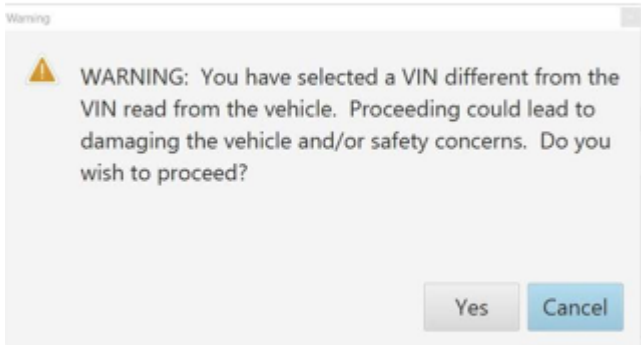
5877000

Important: If the vehicle VIN DOES NOT match, the message below will be shown

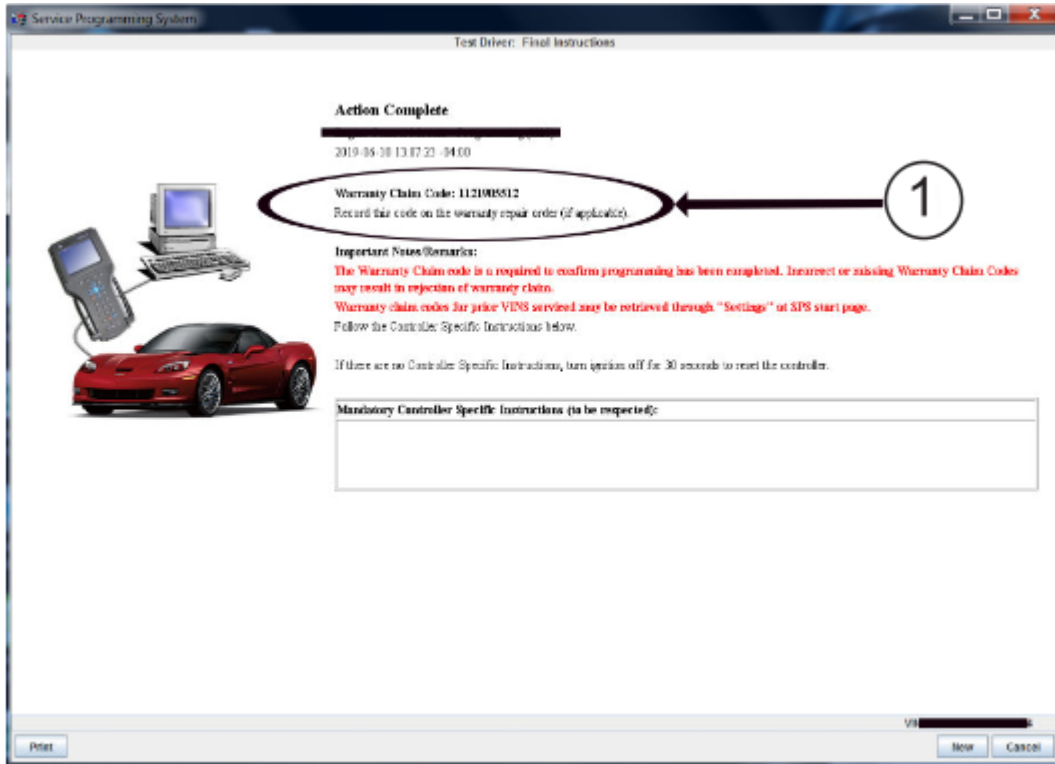
5431209

Important: To avoid warranty transaction rejections, you **MUST** record the warranty claim code provided on the SPS Warranty Claim Code (WCC) screen shown above on the job card. Refer to callout 1 above for the location of the WCC on the SPS screen

- Record SPS Warranty Claim Code on job card for warranty transaction submission.
