**Subject: Unwanted Front Windshield Wiper Swipe, Cruise Control Will Not Turn On, Steering Wheel Controls Inoperative, DTCs P155A SYM00, P1529 SYM03**

Brand:	Model:	Model Year:		VIN:		Engine:	Transmission:
		from	to	from	to		
Buick	Encore	2019	2020	—	—	All	All
Chevrolet	Trax

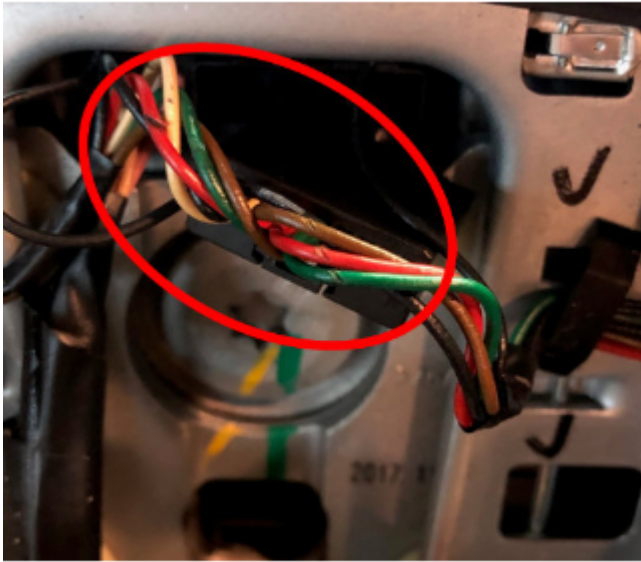
<p>5480325</p>

The cause of the condition may be the steering wheel harness shorted under the steering wheel inflator module.

If you encounter a vehicle with the above concern, inspect and repair the steering wheel harness referring to the proper wire repair procedures. Refer to *Wire to Wire Repair* in SI.
