Service Bulletin

Bulletin No.: 21-NA-248

Subject: A/C Blows Warm Intermittently and/or Takes a Long Time to Start Cooling

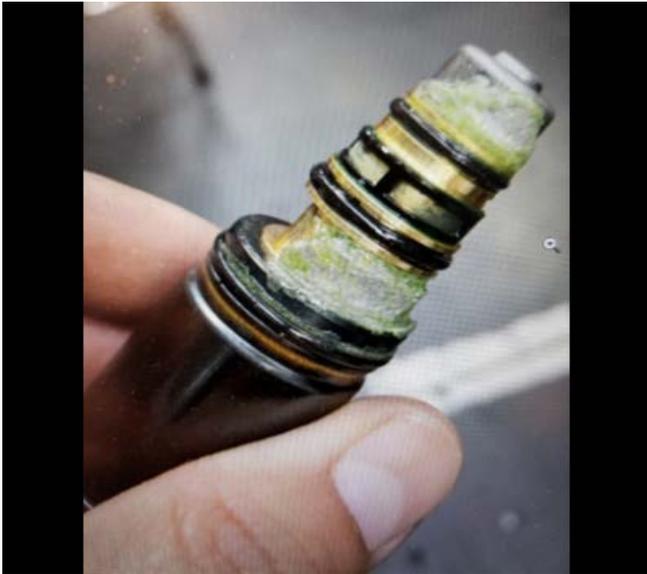
5787215

Shown in the picture above is a contaminated Compressor Solenoid.

If there is solid contamination on just the compressor solenoid you will need to replace just the compressor and receiver/dryer. Note that it is not necessary to replace the condenser, the receiver/dryer is replaceable separately.

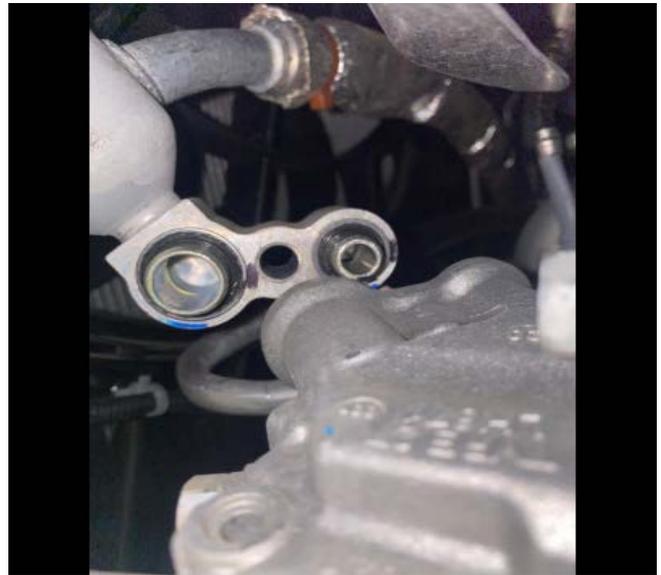
5899621

Shown in the picture above is a clean Compressor Inlet/Outlet (Some oil and greenish dye is normal)

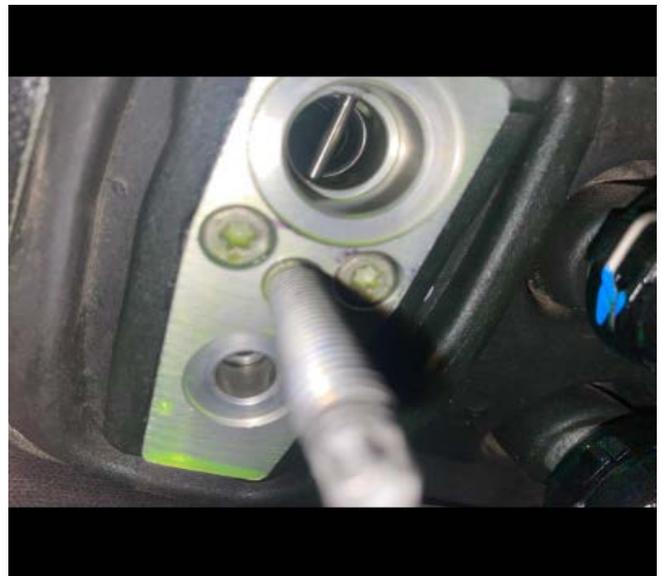
5899622

Shown in the picture above is a clean TXV (Some oil and greenish dye is normal)
