Service Bulletin

Bulletin No.: 21-NA-265

Subject: Coolant Leak Under Truck, Malfunction Indicator Lamp (MIL) Illuminated - DTC P2C48 Set

Brand:	Model:	Model Year:		VIN:		Engine:	Transmission:
		from	to	from	to		
Chevrolet	Silverado 2 500HD/3500HD	2020	2022			L5P	
GMC	Sierra 2500HD/3500HD

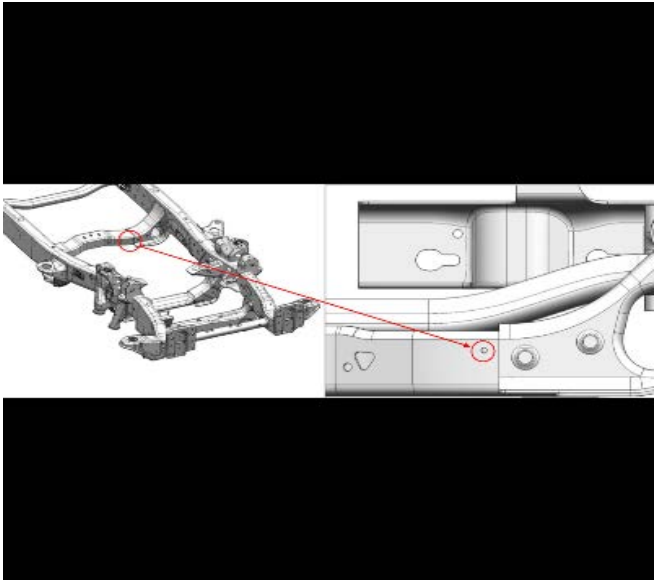
<p>Cause</p>	<p>This condition may be caused by the fuel cooler coolant hose contacting front drive shaft at crossmember. – Typically can happen when driving through deeper water or snow.</p>
<p>Correction</p>	<p>Follow the procedure below to re-route the coolant hose away from the front drive shaft:</p>

<p style="text-align: right;">5924533</p> <ol style="list-style-type: none"> Utilizing a 6.5 mm drill size, drill a hole in the transmission crossmember in the approximate location noted in the graphic above.
