# Service Bulletin

Bulletin No.: 21-NA-267

**Subject:** Exhaust Fumes Or Odor In Cabin Or In the Engine Compartment

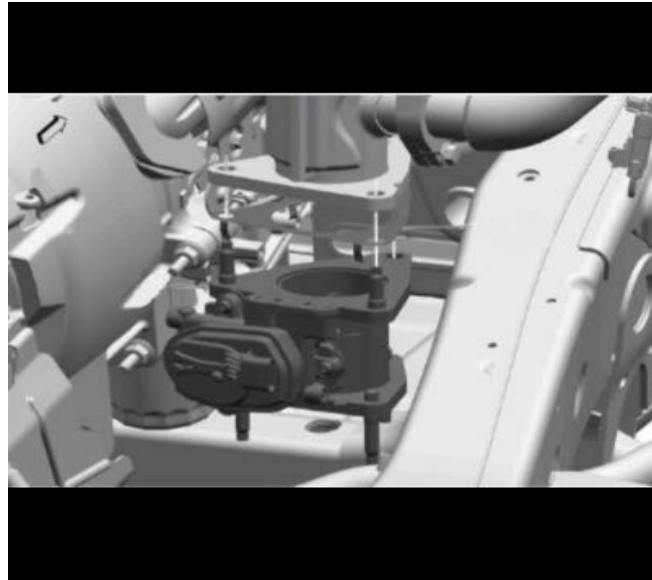
5735432

- The exhaust backpressure valve is located between the downpipe from the SCR w/ filter and the under floor SCR.

**Note:** If the weld joint is leaking, replace the Exhaust Back Pressure Valve.

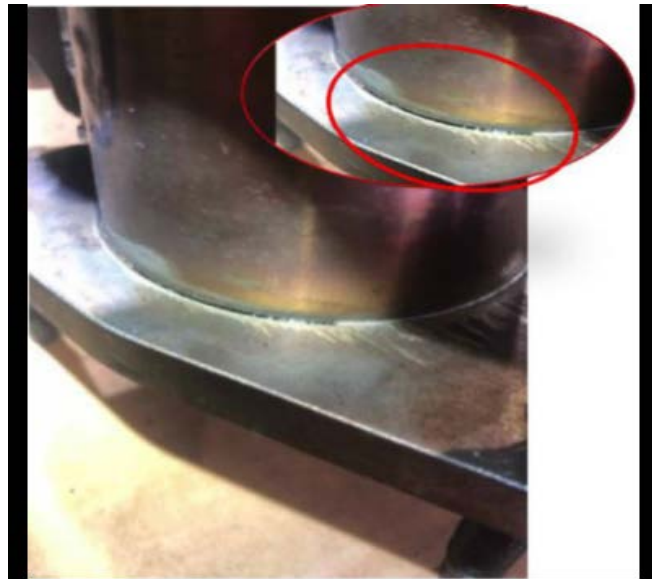
5735765

| <b>Cause</b> | This condition may be caused by an improper weld on the Exhaust Back Pressure Valve. |

- A leak may be caused by an ineffective weld, allowing for a leak at the flange joint.

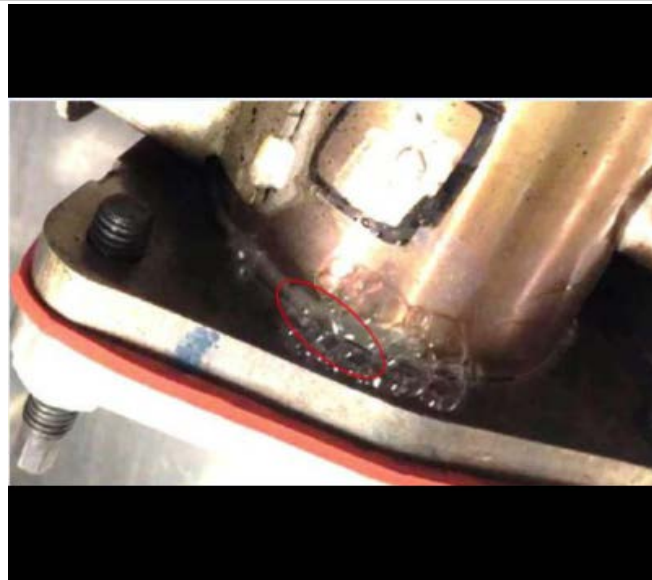
5735764

- Soapy water can be used to identify the leak, though smoke from the GE-52250 is also effective.
