SIB 32 04 20

## GROANING NOISE DURING HEIGHT ADJUSTMENT OF THE ELECTRIC STEERING COLUMN

F90 (M5 Sedan)	F91 (M8 Convertible)	F92 (M8 Coupe)	F93 (M8 Gran Coupe)
F95 (X5 M Sports Activity Vehicle)	F96 (X6 M Sports Activity Coupe)	G05 (X5 Sports Activity Vehicle)	G06 (X6 Sports Activity Coupe)
G07 (X7 Sports Activity Vehicle)	G12 (7 Series Sedan)	G14 (8 Series Convertible)	G15 (8 Series Coupe)
G16 (8 Series Gran Coupe)	G30 (5 Series Sedan)	G32 (640i xDrive Gran Turismo)

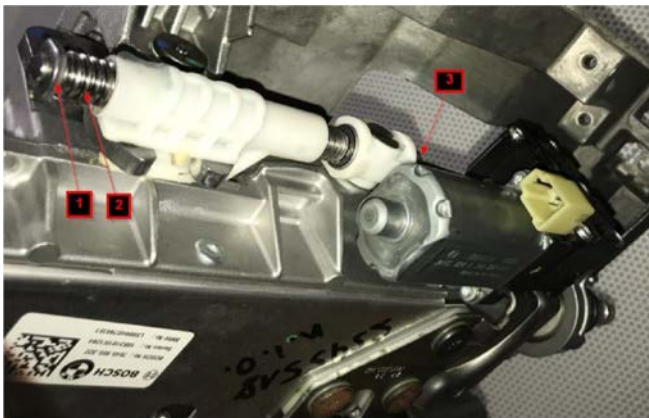
Spindle drive of the electric steering column height adjustment.

The spindle drive (2) is located on the right side of the steering column as viewed from the driver's seat.

The stop panel (1) of the spindle drive will need to be turned 90 degrees clockwise.

Before adjusting the stop spindle, the lock nut in the rear of the drive (3) must be secured in place.

4. With the rear lock nut secured, rotate the stop panel 90 degrees clockwise using a 13 mm open end wrench. See attached video V32 02 20.
