# Service Bulletin

Bulletin No.: 08-03-10-006H

**Subject:** Tire Slowly Goes Flat, Tire Air Loss, Low Tire Pressure Warning Light Illuminated, Aluminum Wheel Bead Seat Corrosion (Clean and Resurface Wheel Bead Seat)

**Models:** 2022 and Prior GM Passenger Cars and Light Duty Trucks

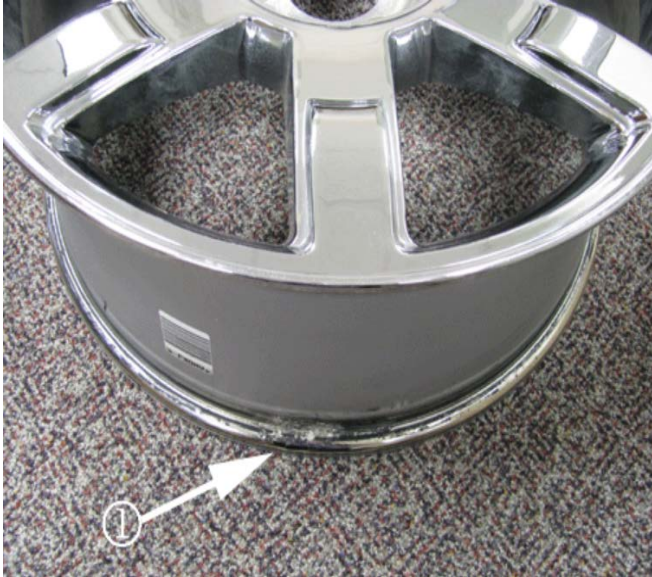
### Typical Location of Bead Seat Corrosion

Abrasive elements in the environment may intrude between the tire and wheel at the bead seat. There is always some relative motion between the tire and wheel (when the vehicle is driven) and this motion may cause the abrasive particles to wear the wheel and tire materials. As the wear continues, there may also be intrusion at the tire/wheel interface by corrosive media from the environment. Eventually a path for air develops and a 'slow' leak may ensue. This corrosion may appear on the inboard or outboard bead seating surface of the wheel. This corrosion will not be visible until the tire is dismantled from the wheel.

1. Remove the wheel and tire assembly for diagnosis. Refer to *Tire and Wheel Removal and Installation* in SI.
2. After a water dunk tank leak test, if you determine the source of the air leak to be around the bead seat of the wheel, dismount the tire to examine the bead seat. Shown below is a typical area of bead seat corrosion.

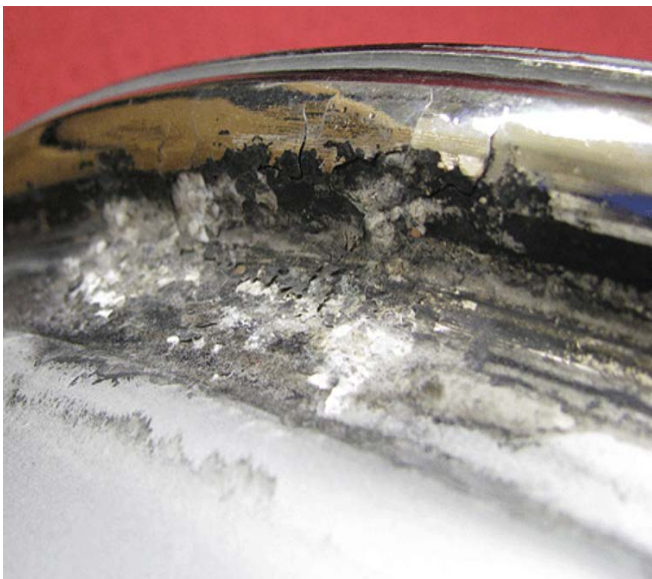
### Close-Up of Bead Seat Corrosion

3. Bead seat corrosion is identified by what appears like blistering of the wheel finish, causing a rough or uneven surface that is difficult for the tire to maintain a proper seal on. Below is a close-up photo of bead seat corrosion on an aluminum wheel that was sufficient to cause slow air loss.

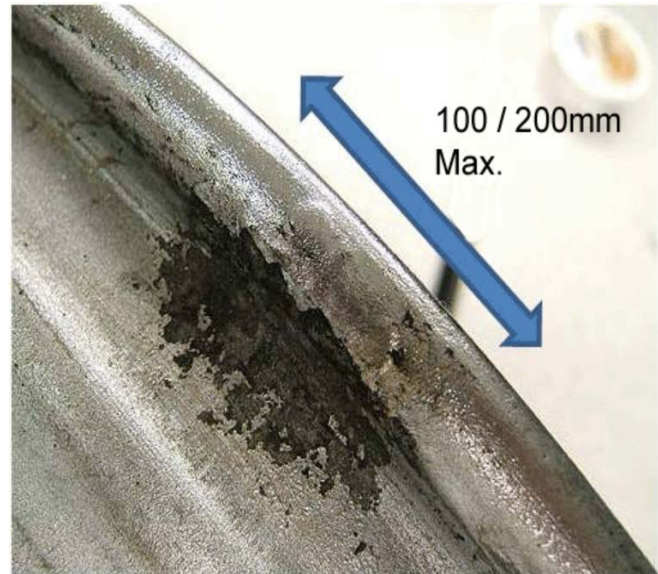
4. If corrosion is found on the wheel bead seat, measure the affected area as shown below.

- For vehicles with 32,186 km (20,000 mi) or less, the total allowable combined linear area of repairable corrosion is 100 mm (4 in) or less. If the total area(s) of corrosion exceed these dimensions, the wheel should be replaced.

- For vehicles that have exceeded 32,186 km (20,000 mi), the total allowable combined linear area of repairable corrosion is 200 mm (8 in) or less. If the total area(s) of corrosion exceed these dimensions, the wheel should be replaced.
