Yellow "Coolant" Message In Instrument Cluster

Topic number	LI20.00-P-073432
Version	1
Function group	20.00 - General
Date	8/4/21
Validity	Model series 167 with M177LS2 48 V
Reason for change

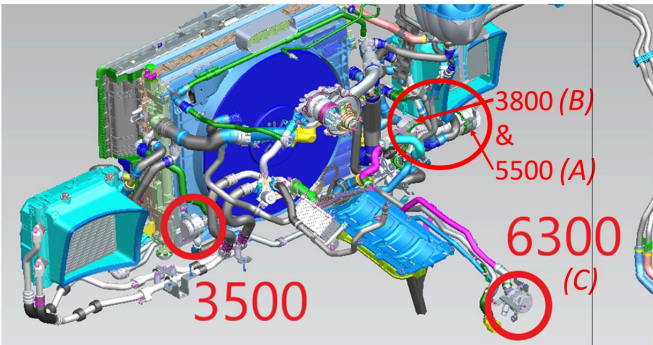
<p data-bbox="111 701 200 730">cuit.jpg</p>	<p data-bbox="801 271 1160 300">Figure 1; positions A, B and C</p>

P2B2A7A - The speed of the 'Coolant pump' component part is too high. A leak or defective seal was detected.

The fault code affects the 15W pump at the rear right of the vehicle. It is located on the side of the transmission (Fig. 1, position C).

This fault code is set because there is air in the system, so it performs an emergency dry run function.

Check the installation position of the pumps at the front right of the low-temperature circuit (Fig. 1) :

Outer: A 000 500 5500 (Fig. 1, position A)

Inner: A 000 500 3800 (Fig. 1; position B)

Order new pump(s) (where the item numbers differ from the specified part number)

Use a vacuum bleeder to fill the cooling system of the low-temperature circuit

Vent the cooling system of the low-temperature circuit using XENTRY.

To start with, the pumps at front right are actuated at approx. 30%, then 50% and finally at 100%. At 100% actuation, the valve of the coolant circulating the pump at the side of the transmission is opened (Fig. 1; position C).

- The pumps at front right (Fig. 1, position A and B) always run together. These pumps must NEVER be operated separately of each other for actuation or for test purposes.
- The pump at the rear of the transmission must run permanently after being actuated. If the pump only briefly starts-up and then stops again, it is in an emergency dry run mode because there is too much air in the system. Please repeat the venting routine. If the rear pump at the side of the transmission remains in the emergency dry run mode, STOP and create a PTSS case, add the previously discovered findings to it and escalate it.
- If venting is successful, very little coolant flow noise will be present. It may be necessary to perform the venting routine several times. If after 3 venting attempts the system still has air in it, STOP create a PTSS case, add the previously discovered findings to it and escalate it.
