## G Facelift 2018: Rear-end (tailgate) door cannot be opened

| Topic number | LI72.20-P-073466 |
| Validity | Model 463 from model year 2021 (with code X20) |

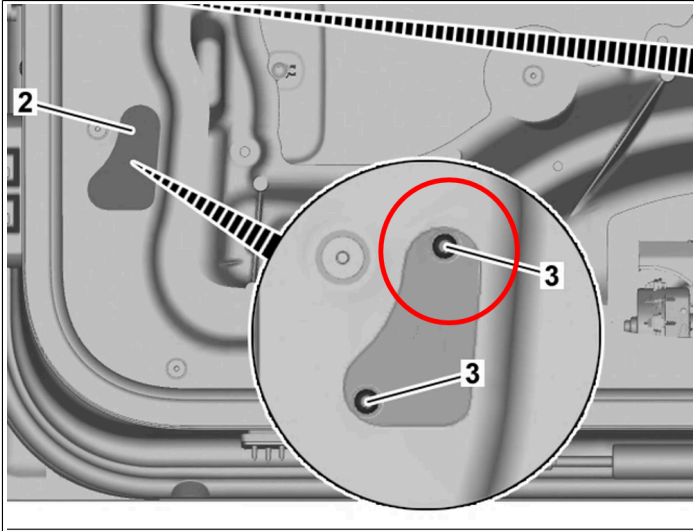
| Attachments | |
|---|---|
| <a href="#">Türinnenblech Bohrung.png</a> | Picture 1 |

The link rod between the door lock and the central locking actuator motor may jump out when locking the vehicle.

1. Remove rear-end door central locking actuator motor AR80.20-p-4003XG (note: only partially detach insulation from rear-end door)
2. Drill out hole of upper mounting screw of actuator motor on inner door panel to 7 mm (Picture1) and seal with primer
3. Drill out hole on actuator motor clip to 5 mm (Picture 2)
4. Place CL actuator motor in position and fasten in place in topmost position (Picture 3)
5. Perform function test.
6. Assemble in the reverse order
