## Water entry at sliding sunroof

| Topic number | LI77.20-P-073486 |
| Function group | 77.20 - Electric sliding roof |
| Validity | Model 463 as of model year 2019 (as of code XZ8) and sliding sunroof (code F15) |

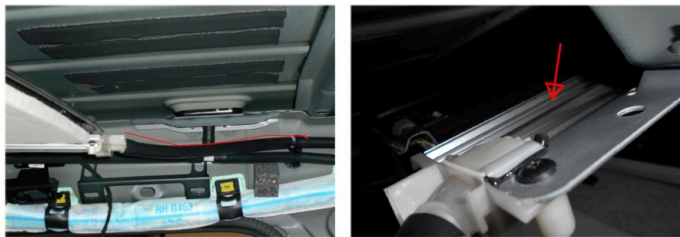
The left rear and right rear water drain hoses on the sliding sunroof frame may be incorrectly routed, with the result that water cannot drain properly due to the lack of a slope.

Water may accumulate at the rear of the sliding sunroof frame (see Picture 1) and subsequently overflow, causing water to enter through the roof lining.

| Attachments | |
|---|---|
| <a href="#">Picture 1 - Waterlogging in drainage channel in sunroof frame.JPG</a><br> | Picture 1 - Description of problem |

Remove the roof lining.

- Route the left rear and right rear drain hoses of the sliding sunroof frame from the upper clip-on point to the lower clip-on point.

- This must be carried out for both fastening points at the C-pillar and D-pillar. Carry out this step on both the left and right side of the vehicle.

- Then move the water drain hoses of the roof luggage rack mounts from the lower clip-on point to the upper clip-on point (see Pictures 2 and 3, Video 1).

Reinstall the roof lining.

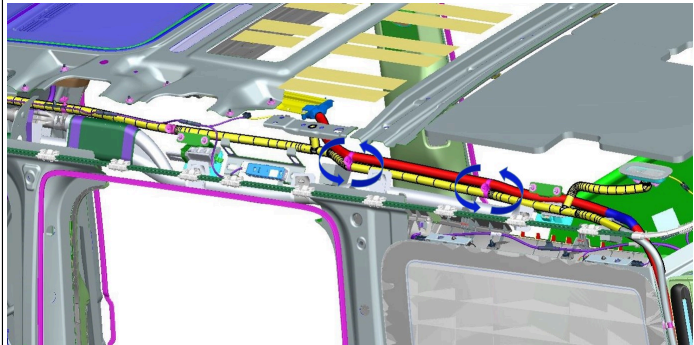
| Attachments | |
|---|---|
| <a href="#">Picture 2 - Swap hoses left vehicle side.JPG</a> | Picture 2 - Rework instruction for left side |

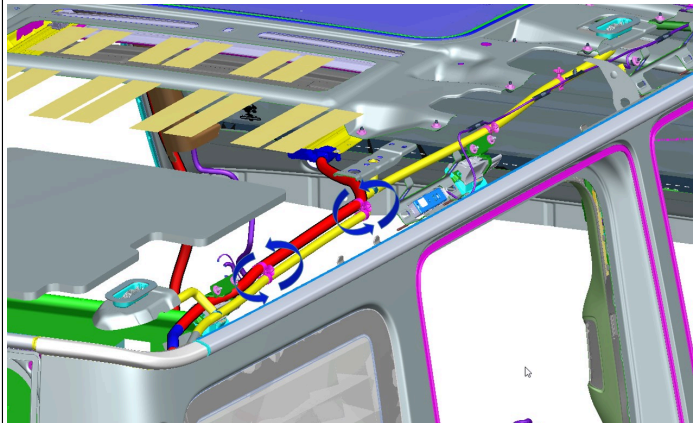
| Attachments | |
|---|---|
| <a href="#">Picture 3 - Swap hoses right vehicle side.JPG</a> | Picture 3 - Rework instruction for right side |
