223 Door Handles Do not Extend when Pressed

Topic number	LI80.61-P-073358
Version	1
Function group	80.61 - Keyless-Go/Keyless-Entry
Date	7/23/21
Validity	MODEL 223
Reason for change	Adaptation of complaint, remedy, cause

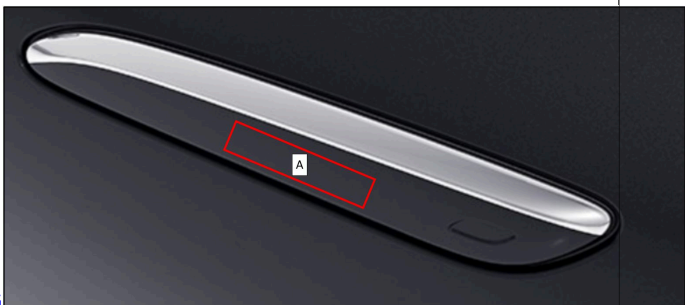
1.JPG	Picture 1

The flush-mounted door handles are retracted and do not extend electrically in response to a command from the door handle (sensor in center of door handle is touched (see Picture 1, A)), so that the door can be opened.
