## Rear Passenger Compartment Interior Lighting Nonfunctional

| Topic number | LI82.20-P-073522 |
| Validity | Model series 223 with code 236 (Adaptive rear compartment lighting) |

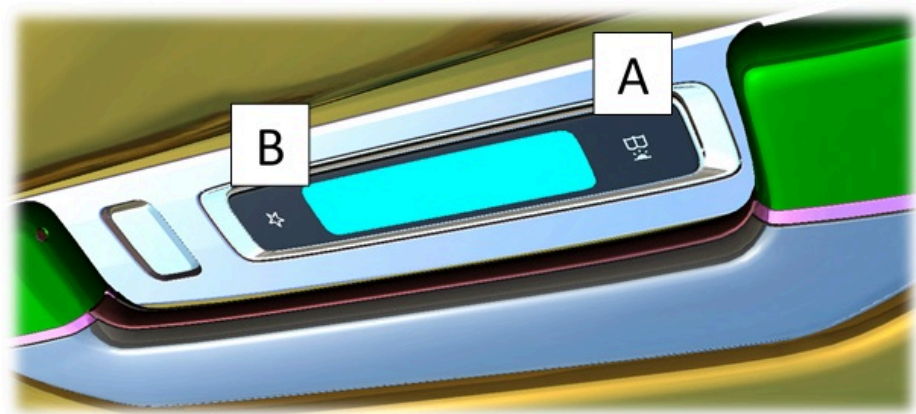
1. Ignition is on (KL15)
2. Interior lighting is off
3. Operate reading light pushbutton switch (A) in grab handle lamp  
=> reading light only goes on in grab handle lamp
4. Operate reading light pushbutton switch (A) in grab handle lamp again  
=> Reading light only goes off in grab handle lamp
5. Operate favorites pushbutton switch (B) in grab handle lamp  
=> Interior lighting goes on in both grab handle lamps + additional lamps
6. Operate favorites pushbutton switch (B) in grab handle lamp again  
=> Interior lighting goes out in both grab handle lamps + additional lamps

Manually check reading light and interior lighting after coding.
