Noise On Upper Instrument Panel Cover (Center-Fill Grill) In Model Series 213, 238, or 257

Topic number	LI68.10-P-064592
Version	12
Function group	68.10 - Instrument panel
Date	9/14/21
Validity	BR213, BR238, BR257
Reason for change	Creation of TIPS case and analysis sheet no longer required

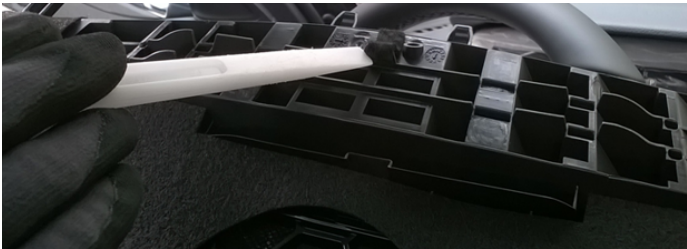
Cover (centerfill grille) touches instrument panel.

Attachments	
File	Description
Abdeckung Instrumententafel oben Pic.1.JPG	A rib is located at this point on the component. A 10x2x25 mm piece of felt must be fitted over this rib.

Cut felt to size 10X25 mm.

Apply felt to marked area (Pic. 1).

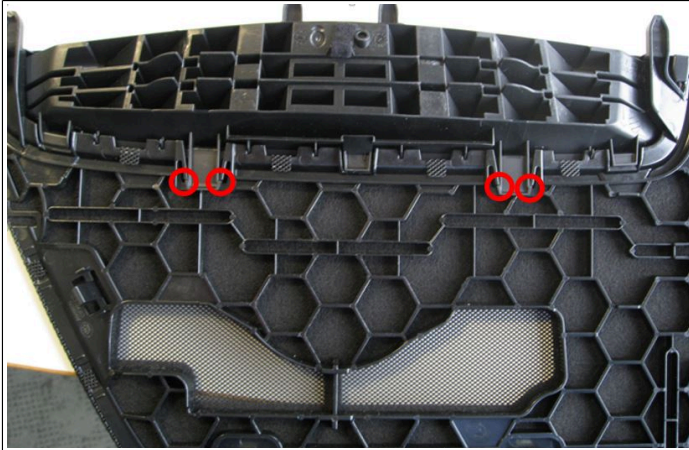
Abdeckung Instrumententafel oben Pic.2.JPG	Apply coating of Krytox to these points

Apply light coating of Krytox A000 989 36 60 to clip contact areas (Pic. 2).
