Campaign No. 2021090006, September 2021

SUBJECT: **Model CLA-Class (118 platform)**
Model Year 2021

Check Spare Wheel Well for Moisture

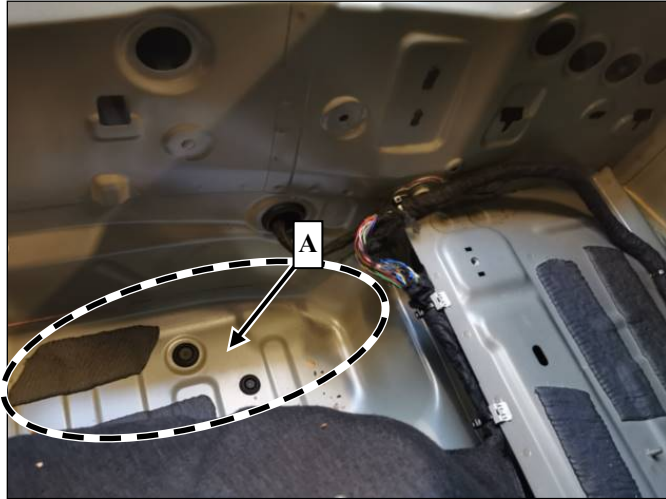
Figure 1

1. Open trunk lid
2. Lift cover of spare wheel well.
3. Check area of spare wheel well (A, Figure 1) for moisture/water.

- a. **Moisture/water present** in spare wheel well: Carry out **work procedure**.
- b. **Moisture/water not present** in spare wheel well: **End measure**.

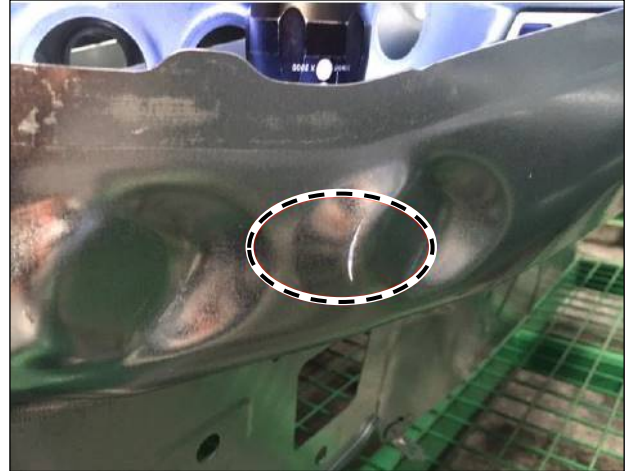
Figure 3

Mercedes-Benz AG (“MBAG”), the manufacturer of Mercedes-Benz vehicles, has determined that on certain MY 2021 CLA-Class (118 platform) vehicles, the left rear section under the spare wheel well may not correspond to current specifications and may have developed a crack. This might allow water to enter into the spare wheel well. MBUSA will conduct a service campaign. An authorized Mercedes-Benz dealer will check the spare wheel well for moisture on the affected vehicles and rework the respective area, if necessary.

1. Remove rear bumper.
i For basic data, see AR88.20-P-2200MFA.
2. Remove left rear radar sensor mount (B, Figure 2).
3. Drill off crack on left in rear-end center section (Figure 3), weld shut, blend paint, and apply a cavity protection agent.
i Important: Inner area of cavities/flanges in rear-end center section
