GROUP
Product Improvement

NUMBER
PI1803Y/Z (Rev 6, 12/23/2021)

PRODUCT IMPROVEMENT CAMPAIGN

ENGINE REPLACEMENT INSTRUCTIONS FOR DTC P1326 (PI1803Y/Z)

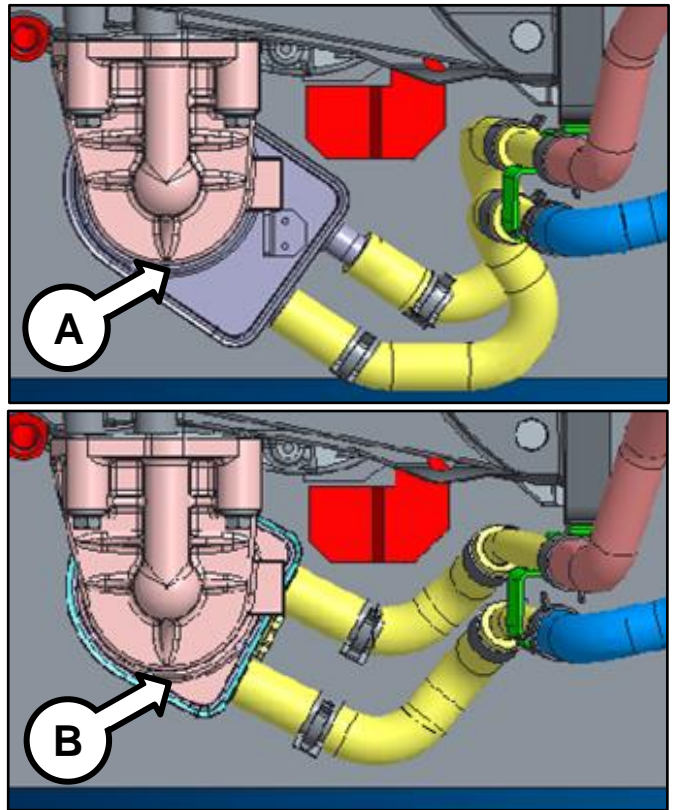
Oil Cooler Tube Assembly:

New engines may be supplied with a different oil cooler. Use steps below to determine the need for a replacement oil cooler tube assembly.

- If the new engine's (bigger) oil cooler (A) does not match the old engine's (smaller) oil cooler (B), replace the oil cooler tube assembly with the improved part. See parts table on page 23.
- If the new engine's (bigger) oil cooler (A) matches the old engine's (bigger) oil cooler (A), reuse the old engine's oil cooler tube assembly.
- If the new engine's (smaller) oil cooler (B) matches the old engine's (smaller) oil cooler (B), reuse the old engine's oil cooler tube assembly.
