**SERVICE BULLETIN**

**APPLICABILITY:** 2019MY Ascent **NUMBER:** 05-72-19R  
**SUBJECT:** Squeak / Creaking Sound from Rear Suspension **DATE:** 12/10/19  
**REVISED:** 12/06/21

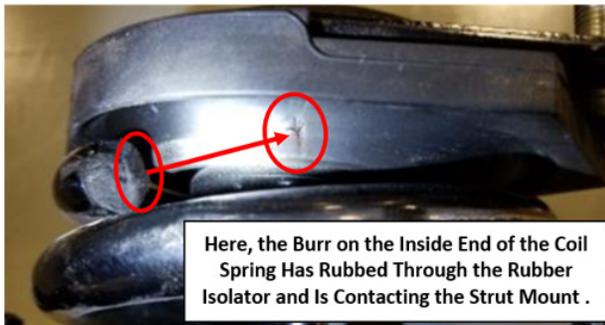
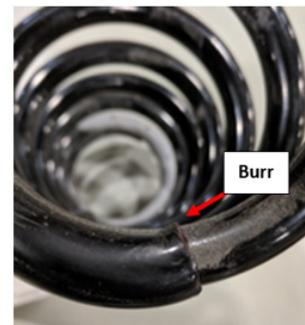
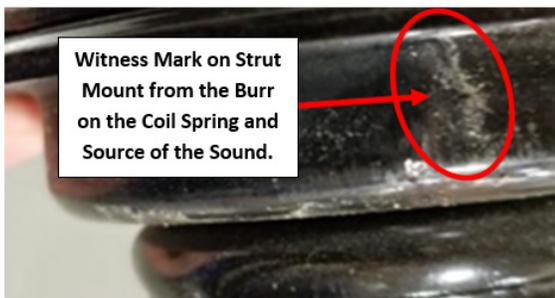
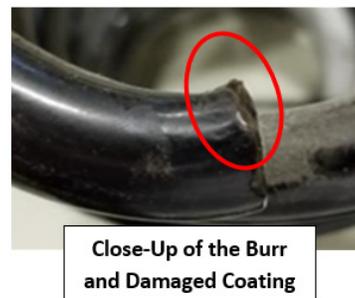
This bulletin addresses isolated concerns of a squeaking / creaking -type sound from the rear suspension. The condition is caused by a burr on the end of the coil spring winding produced with an end gap which was out of specification. This allowed the burr to make contact with the mount. Over time, the burr, which is characteristic result of the manufacturing process, can penetrate the rubber isolator and come into direct contact with the strut mount as shown in the photos below. This contact creates the sound described. Should this occur, both the mount and coil spring must be replaced. **NEVER attempt to grind or otherwise alter the burr on the new or original equipment coil spring** or repair any contact marks with paint or other coatings. Replace the affected parts with new ones.

- **The burr is a normal characteristic of the spring production process. NEVER** attempt to grind or file it away as this will reduce the corrosion resistance of the spring, even if painted or re-coated.
- If the burr has punctured through the rubber isolator and contacted the steel portion of the strut mount, the strut mount must be replaced.
