# TECH TIPS GREATEST TIPS

## ERRATIC DIGITAL FUEL GAUGE OPERATION, 2012MY AND LATER IMPREZA, BRZ AND 2014MY FORESTER

## 01 Sending Immobilizer Components, Broken on Arrival

## 15 B2255 and B2256 misdiagnosis and Diagnostic changes

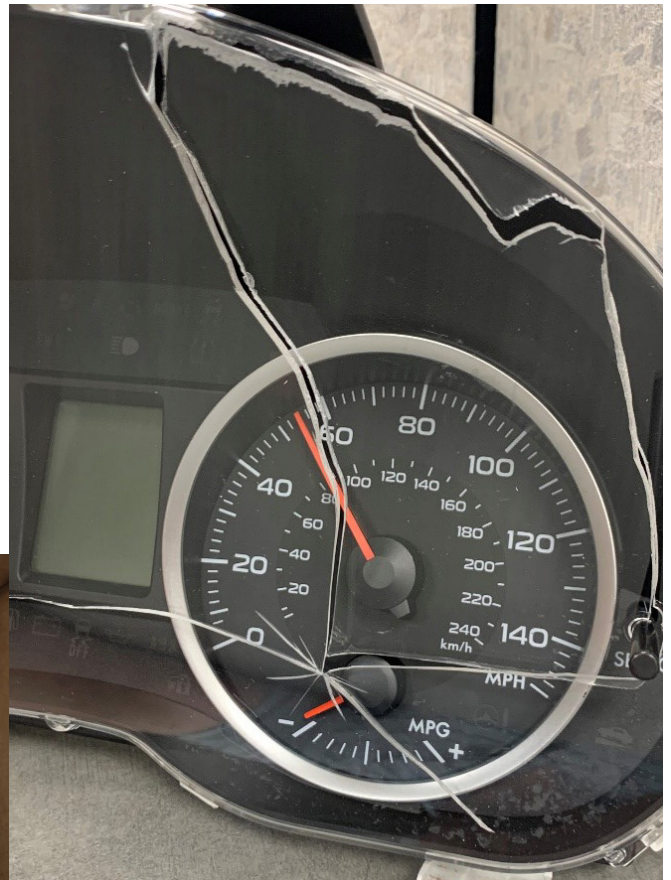
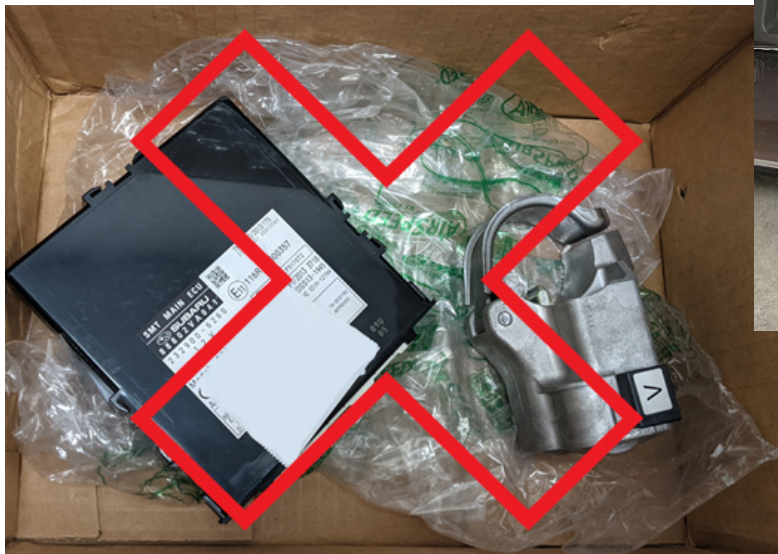
Techline has received several broken immobilizer components in recent months for lost key reprogramming. This has been attributed to poor choices of packing material (or lack thereof), and inadequate box size. The most common parts found broken on arrival to SOA are the combination lens and meter mounting tabs.

When sending components for clearing, take extra consideration and care when packing. Using the proper insulating material and box size could be the difference between a broken meter or not. Inflatable bags are not recommended they are not reliable and can easily deflate.

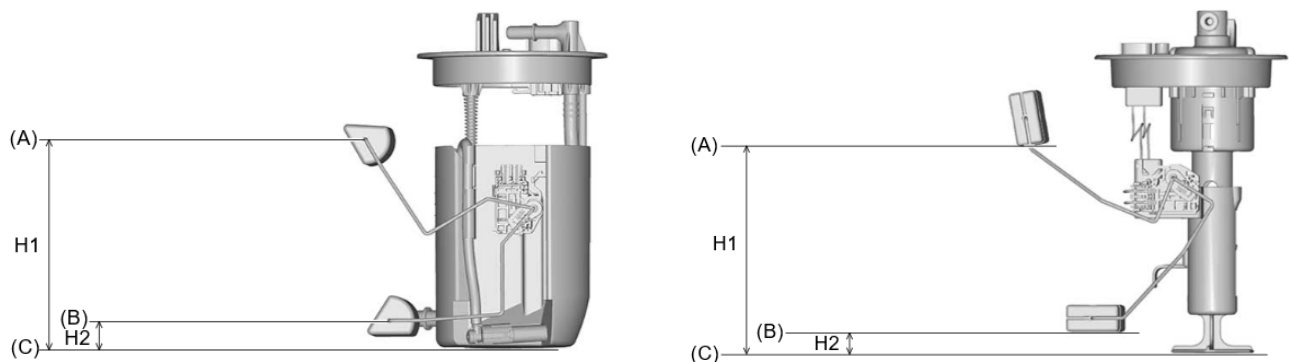
Diagnosis for fuel level discrepancies requires inspection of the combination meter, body harness, both level senders, and the fuel tank. The circuit of the fuel level senders is a loop from the combination meter through both senders, wired in series, that returns back to the combination meter. Subaru's system increases circuit resistance as the fuel level decreases.

A customer may have the concern of the fuel gauge never reading full after fill ups or that they run out of gas while there is still fuel showing on the gauge. The diagnosis is the same for either event. Using the SSM, the combination meter PID should be observed in work support for the circuit resistance. Once that value has been recorded, the total circuit resistance should be checked with a DVOM to confirm the meter is reading the resistance correctly. If the resistance does not match, the combination meter may be at fault.

If the combination meter is correctly reading the resistance of the harness, the senders should be checked for accuracy of the resistance. Each sending unit should have a sweep test performed. The Technician should confirm the minimum and maximum resistance are within the specification posted in STIS. The swept height of the sender arm should be measured to ensure the arm is not bent. The tank should be inspected for any obstacle that may limit the travel of the fuel sender arm in either direction. Damage to the tank or distortions may also impact the accuracy of the level sender.

If the resistance of each sender is within specification and the travel of the senders are not restricted, a harness check should be performed. If any excessive resistance or shorts are found in the harness, it should be replaced.

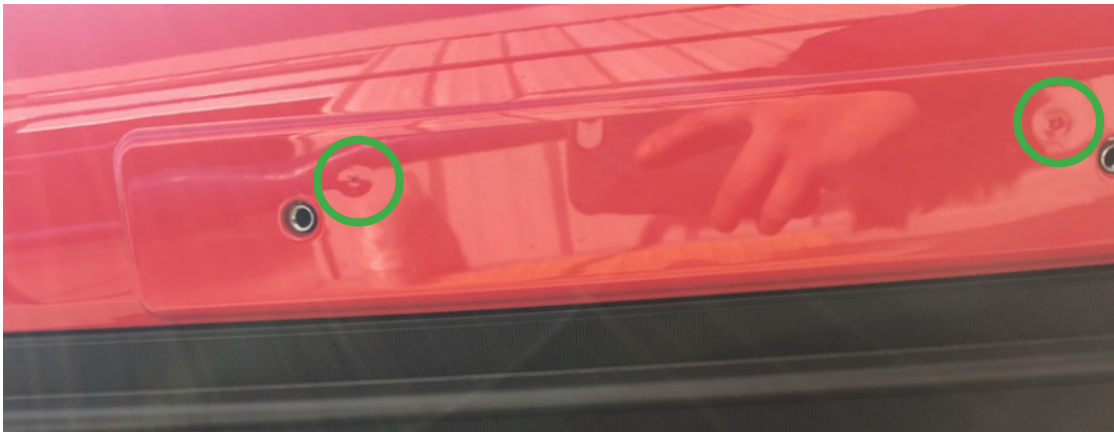
Front Bumper

With the all-new 2022 BRZ launch underway, SOA has seen some concern from the field regarding installing front and/or rear license plates. Thank you for bringing this concern to our attention! Please read below for clarification on installing both front and rear license plates on the 22MY BRZ.

For front and rear license plates, Retailers should utilize self-tapping screws and the dimpled areas (green circles in below pictures) on the bumper facias. The collars pre-installed in the vehicle's front bumper face are for mounting plates in other markets (Example: EU and JDM). **NOTE:** The rear bumper has two sets of dimples, one outside set and one inside set. Retailers should use the inside set of dimples.

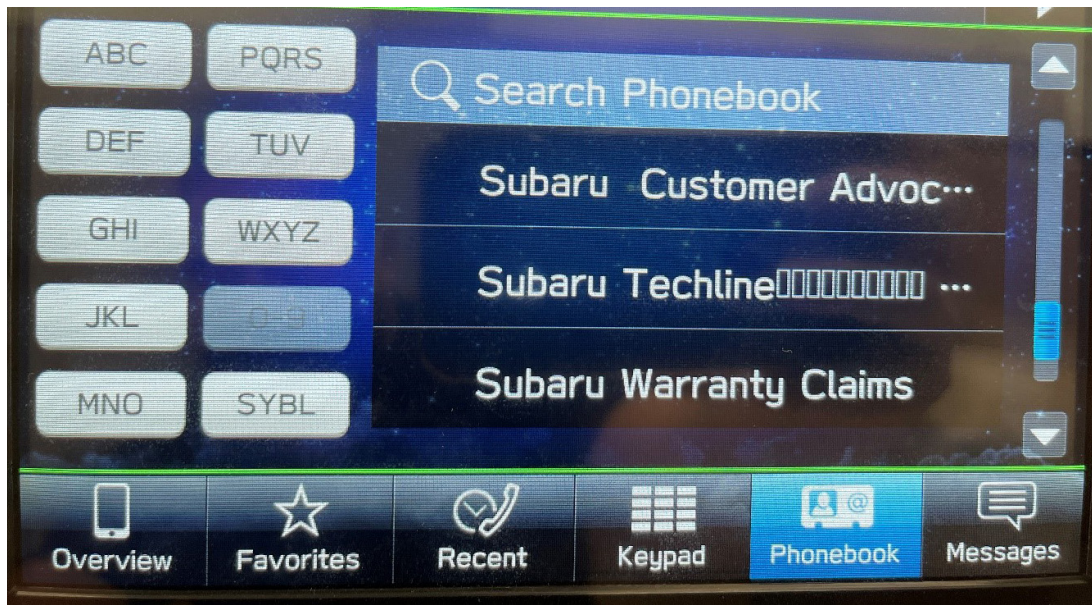
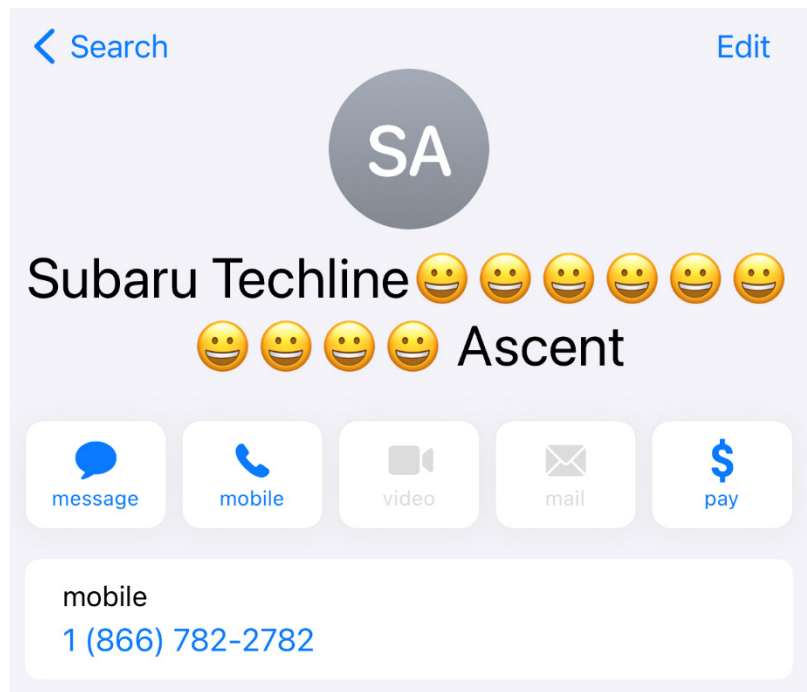
Techline has received reports about the “Call” voice command via Bluetooth being inoperative at times. Upon further inspection with the customer’s phone, it was found only certain contacts trying to be called were affected. The condition was then traced back to those contacts containing emojis in their title name. The Harman platform does not know how to interpret emojis. As a result, the contact may present as a square tile or, ignore the existence of the contact all together when voice command is activated. This condition is only with a single press of the voice command button. A long push to activate Siri or Google will activate the phone’s native voice command which can interpret the emoji correctly.

Here is an example image of the condition using an iPhone platform. Take note that the condition can happen with any emoji in any order. The head unit displays the emoji as square tiles. If the contact’s name is edited or a change is made, a resync with the Bluetooth pairing and phonebook download must be completed. Certain setups may require the Bluetooth pairing to be deleted entirely and paired again followed by re-enabling a phonebook download. This condition does not affect Denso CP1 units.
