Engine Will Not Start: Checking Engine Ground Strap (174/21)

Model Lines: **718 Boxster (982) / 718 Cayman (982)**

Model Year: **As of 2019**

Concerns: **Engine ground strap**

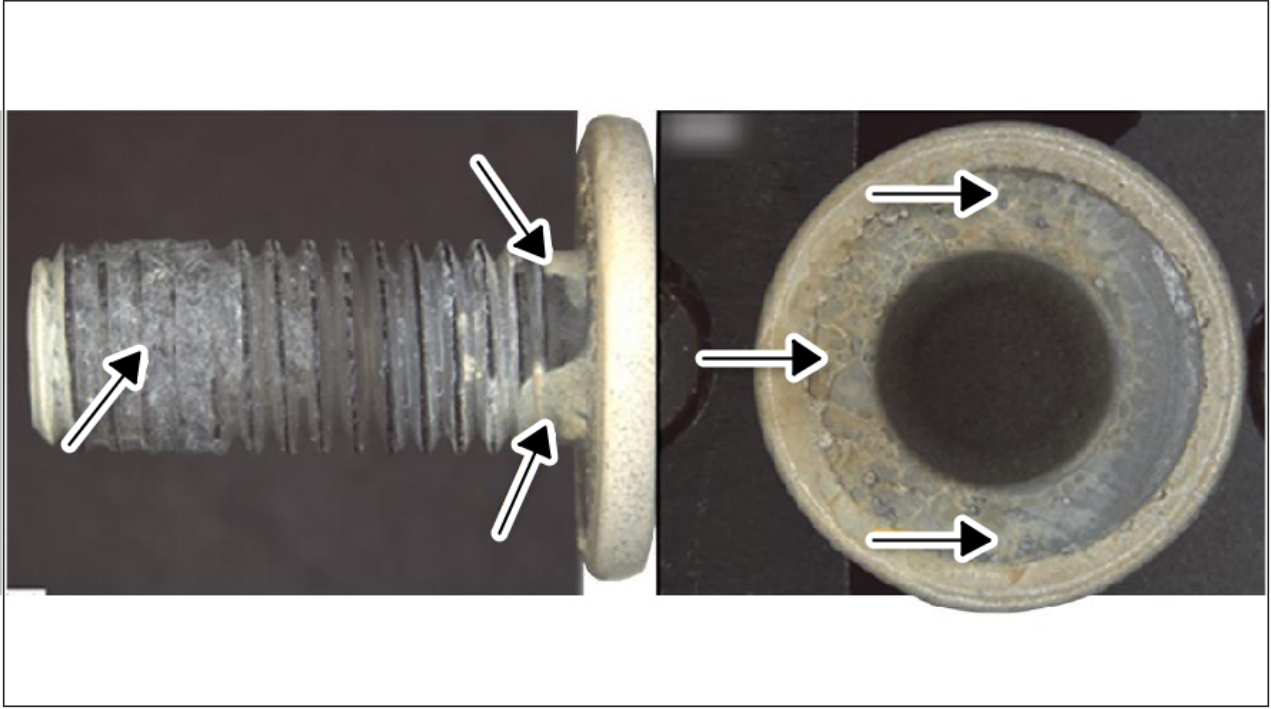
Information: Component analyses of replaced starters have shown that the starter was generally free of faults and was not the cause of engine starting problems. Instead, the cause is usually due to poor electrical contact of the ground strap between the engine and body.

Paint contamination on ground screws

Action required: Check ground connection of the engine.

- 3 Check ground strap and fastening screw and brush off if necessary or clean with sandpaper.
- 4 Installing ground strap.
 Threaded joint on cylinder head: **Tightening torque 23 Nm**
 Threaded joint on body: **Tightening torque 23 Nm**

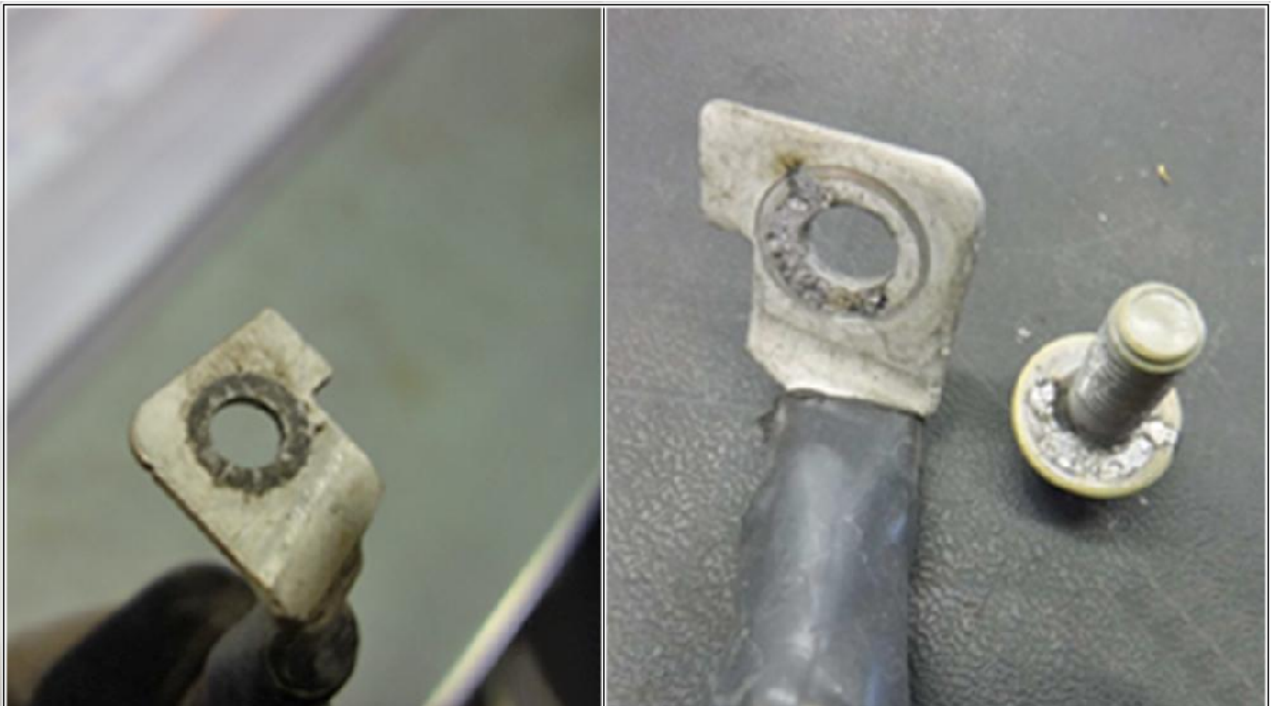
- Paint contamination and corrosion on ground screws or ground strap
- Ground screws not tightened properly

Fault type – ground strap and ground screws
