Complaint - Grease Leaks at the Lower Control Arms of the Front Axle: Check and Clean Control Arms (187/21)

Model Line: **Taycan (Y1A) / (Y1B)**

Model Year: **As of 2020**

Concerns: **Transverse control arm front axle**

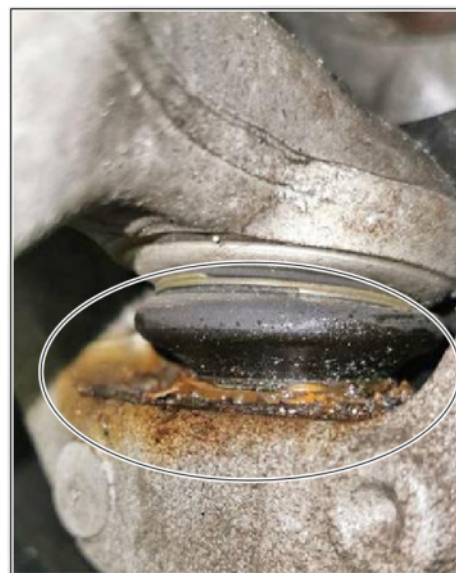
Due to the process, grease may leak during the initial assembly of the control arms due to a maximum deflection of the conical spigot before the control arm is screwed into the wheel carrier. Over the service life, additional foreign bodies can collect in the corresponding area and stick to the excess grease, which can then be distributed over a larger area.

Example of grease leaks

Action required: If there is no customer complaint about noises (rattling, pinching, creaking) from the area of the front axle and the lower control arms have no clearance, remove excess grease and check the ball pin bellows for damage.

If the ball pin bellows is not damaged, the lower control arm **does not** need to be replaced.

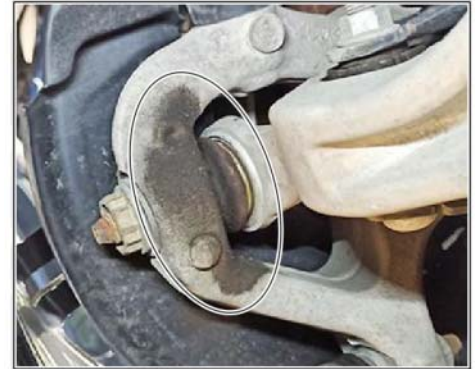
Example of grease leak 2
