Symptom - Rattling Noise from Around the Rear Window: Reworking Electric Connectors for Heated Rear Window (SY 184/21)

Vehicle Type: **Taycan Cross Turismo (Y1B)**

Model Year: **As of 2021**

Concerns: **Electric plug connections for heated rear window**

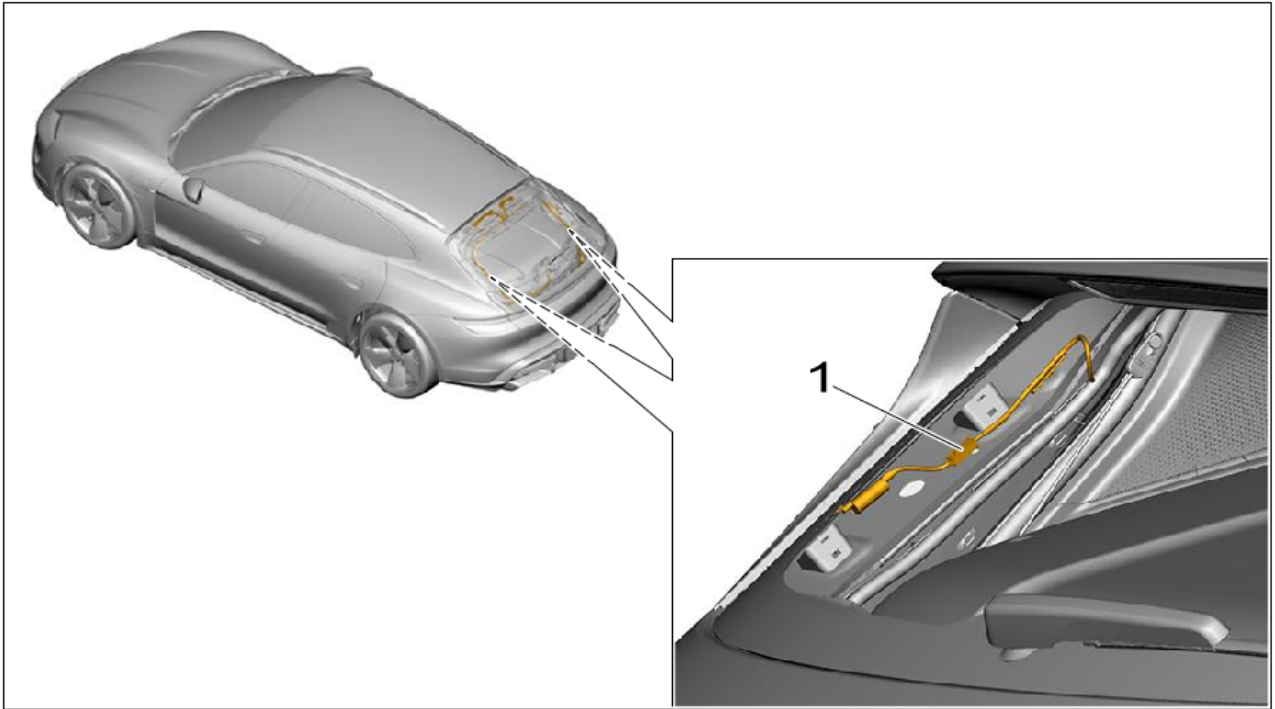
Position of electric plug connection

Cause: This may be caused by the electric plug connection for the heated rear window on the left and/or right-hand side of the vehicle, which does not have a fixed installation position and therefore in the event of vibrations, e.g. while driving, has contact with the rear window or components in the vicinity.

Work Procedure: 1 Release and disconnect electric plug connection. ⇒ *Position of electric plug connection -1-*
