Warning Message "Coolant Temperature Too High": Checking Coolant Pump and Change-Over Valve (173/21)

Model Line: **Panamera (971)**

Model Year: **As of 2017**

Concerns: **Change-over valve for coolant pump**

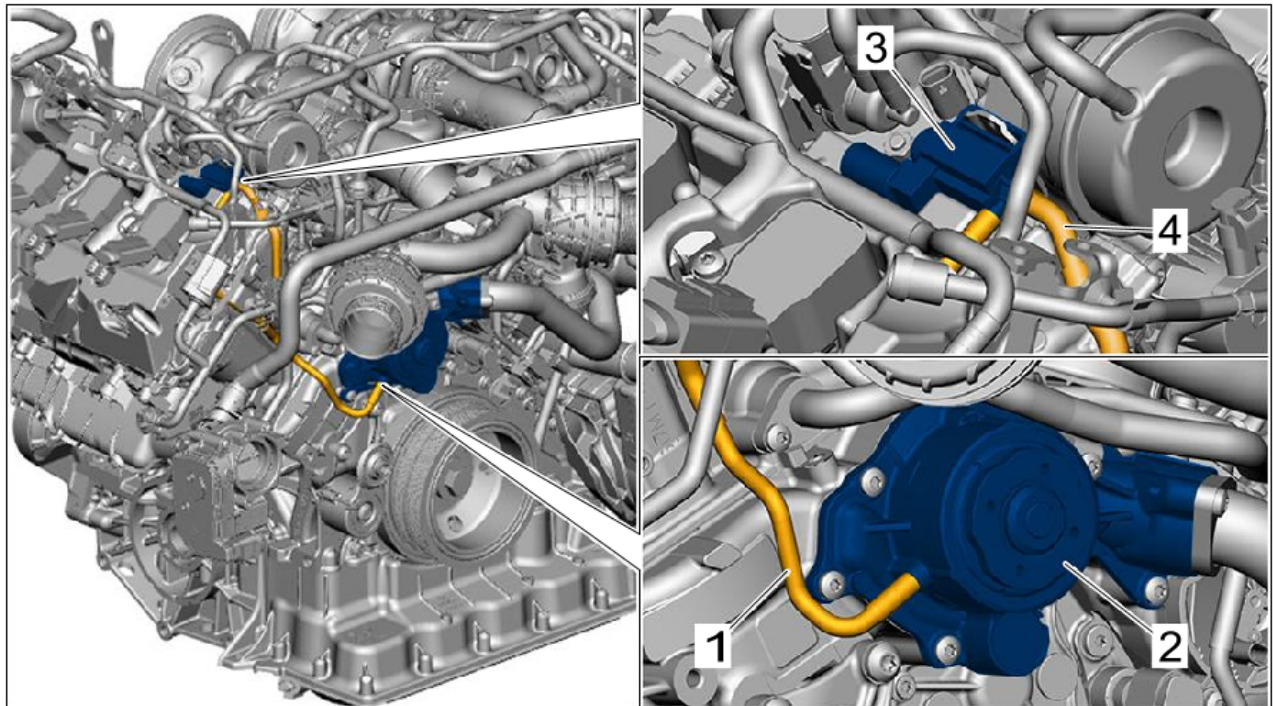
Position of change-over valve and coolant pump

- 1 Pull vacuum hose ⇒ *Position of change-over valve and coolant pump -1-* off the coolant pump ⇒ *Position of change-over valve and coolant pump -2-*.
- 2 Pull off vacuum hose ⇒ *Position of change-over valve and coolant pump -4-* from the control valve ⇒ *Position of change-over valve and coolant pump -3-*.
- 3 **VAS 6213 - Hand vacuum pump** must be ⇒ *Position of change-over valve and coolant pump -3-* connected to the change-over valve ⇒ *Position of change-over valve and coolant pump -4-* on the vacuum hose connection. Then build up vacuum.

Stop the test procedure if a vacuum cannot be built up. In this case, the change-over valve is faulty and must be replaced. Continue with Step 5. If a vacuum can be built up, continue with Step 4.

- 4.2 Select the **Drive links/checks** menu.
- 4.3 Select **Drive links** and press •F12" Next to confirm.
- 4.4 Select '**Activation of vacuum switchover valve for main coolant pump**' and press •F8" to start.
 - If the vacuum in the vacuum pump display changes, the change-over valve ⇒ **-3-** is intact. Continue with Step 4. In this case, only ⇒ **-2-** replace the coolant pump if it is faulty.
 - If the vacuum in the vacuum pump display does not change, the change-over valve ⇒ **-3-** and the coolant pump, if necessary, must be ⇒ **-2-** replaced if the coolant pump is ⇒ **-2-** also faulty.

- 5 **VAS 6213 - Hand vacuum pump** must now be disconnected from the vacuum hose ⇒ **-1-**.
- 6 Install vacuum hose ⇒ **-1-** on coolant pump ⇒ **-2-**.
