Technical Service Bulletin

Subject: RUSTY PANEL AT BOTTOM (INNER SIDE) OF DOORS	Bulletin No.: 09-009/21
	Last Issued : 12/17/2021

2017-2021 CX-5
2016-2021 CX-9

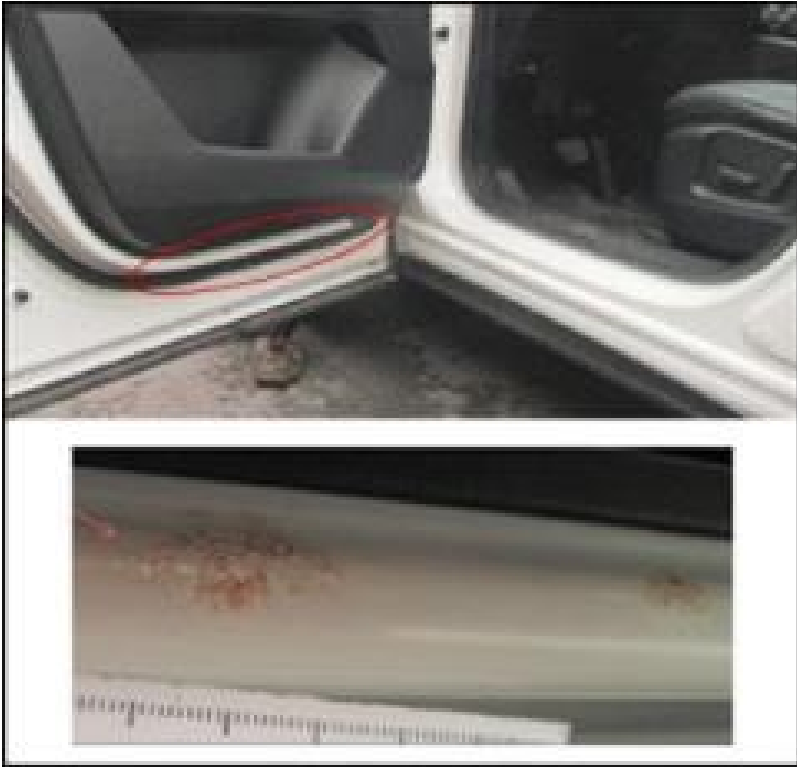
Some customers may complain about rust at the bottom (inner side) of the doors where the seaming welt is located. It is caused by mud/sand adhering to the side sill, which scratches the paint surface when the door is opened/closed. The mud/sand is most likely brought in by the driver and/or passenger when stepping in and out of the vehicle.

1. Verify the customer concern.
2. Repair the paint rust/blister damage on the affected door panel(s) according to normal bodyshop repair procedures.
3. After the paint repair has been completed, attach the protection film to the door panels according to steps a ~ f below.

NOTE: Attach the protective film to all (4) four door panels, even those without any paint rust/blister damage.
