Technical Service Bulletin

Subject: FUEL-FILLER LID PANEL IS DEFORMED	Bulletin No.: 09-019/21
	Last Issued : 12/02/2021

2019-2021 Mazda3
2020-2021 CX-30

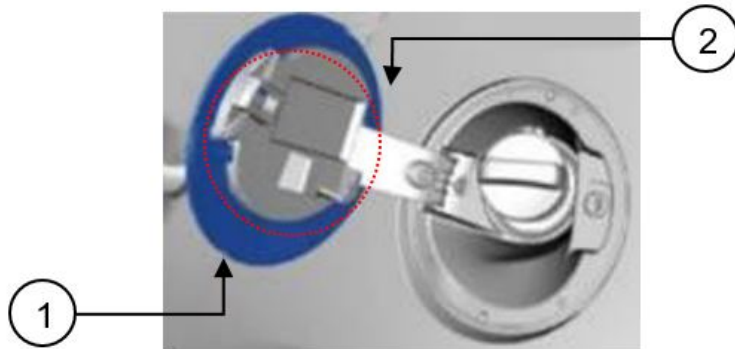
Some vehicles may exhibit a deformed fuel-filler lid panel (1) attached to the fuel-filler lid box, resulting in a poor appearance.

This concern is caused by the lid box not having enough water drainage capability which leads to the accumulation of water inside it. The water then freezes in cold weather and expands or the inner side of the lid panel absorbs the water and swells from long exposure, deforming the lid panel. To eliminate this concern, the shape of the fuel-filler lid box has been modified to have better drainage capability and a modified fuel-filler lid panel service part has been established for less water absorbance.

1. Verify customer concern.
2. Replace the fuel-filler lid panel (1) with a modified one according to the instructions on MGSS.
 - Mazda3 (FUEL-FILLER LID REMOVAL/INSTALLATION)
 - CX-30 (FUEL-FILLER LID REMOVAL/INSTALLATION)
