REAR OUTER DOOR HANDLE FAILS TO RETURN DUE TO WATER FREEZING IN THE HANDLE

Bulletin No.: 09-038/21

Last Issued : 12/16/2021

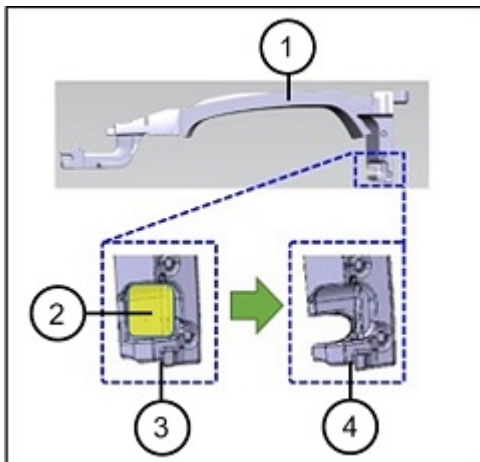
Some vehicles may exhibit the rear outer handle remains pulled out and does not return when the rear outer handle is operated in freezing temperatures. This is caused by the accumulation of snow on the rear outer handle melting and dripping water on the sliding part of the lever. When the water freezes due to decreased temperature and the handle is operated, peeled ice gets caught between the outer handle case and the slide, causing the return failure.

To eliminate this concern, the shape of the rear outer handle (1) has been changed to prevent the accumulation of water (2) on the sliding part of the lever.

(Before modification (3) and After modified (4)).

1. Verify customer concern.
2. Replace both rear outer handles with modified ones according to the instruction on MGSS.
 - Mazda3 (REAR OUTER HANDLE REMOVAL/INSTALLATION)
 - CX-30 (REAR OUTER HANDLE REMOVAL/INSTALLATION)
3. Verify repair.
