<b>Subject:</b>  <b>CONNECTED VEHICLE SYMPTOM TROUBLESHOOTING</b>	<b>Service Alert No.: SA-013/21</b>
	<b>Last Issued : 12/22/2021</b>

2019-2022 Mazda3  
 2020-2022 CX-30  
 2021-2022 CX-5  
 2021-2022 CX-9  
 2022 MX-30

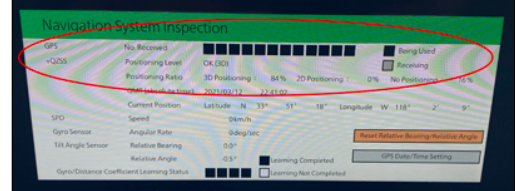
**Good** - Contact Hotline for technical support

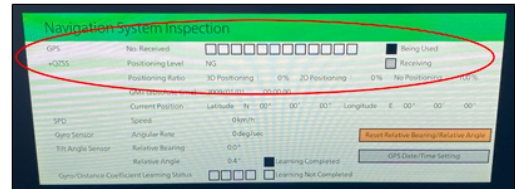
**No Good** - Swap Tel antenna No. 1 with known good vehicle
