**Title:** 2021 A26 Low Power in Cold Climates

**Applies To:** All Models Equipped with 2021 A26 engine

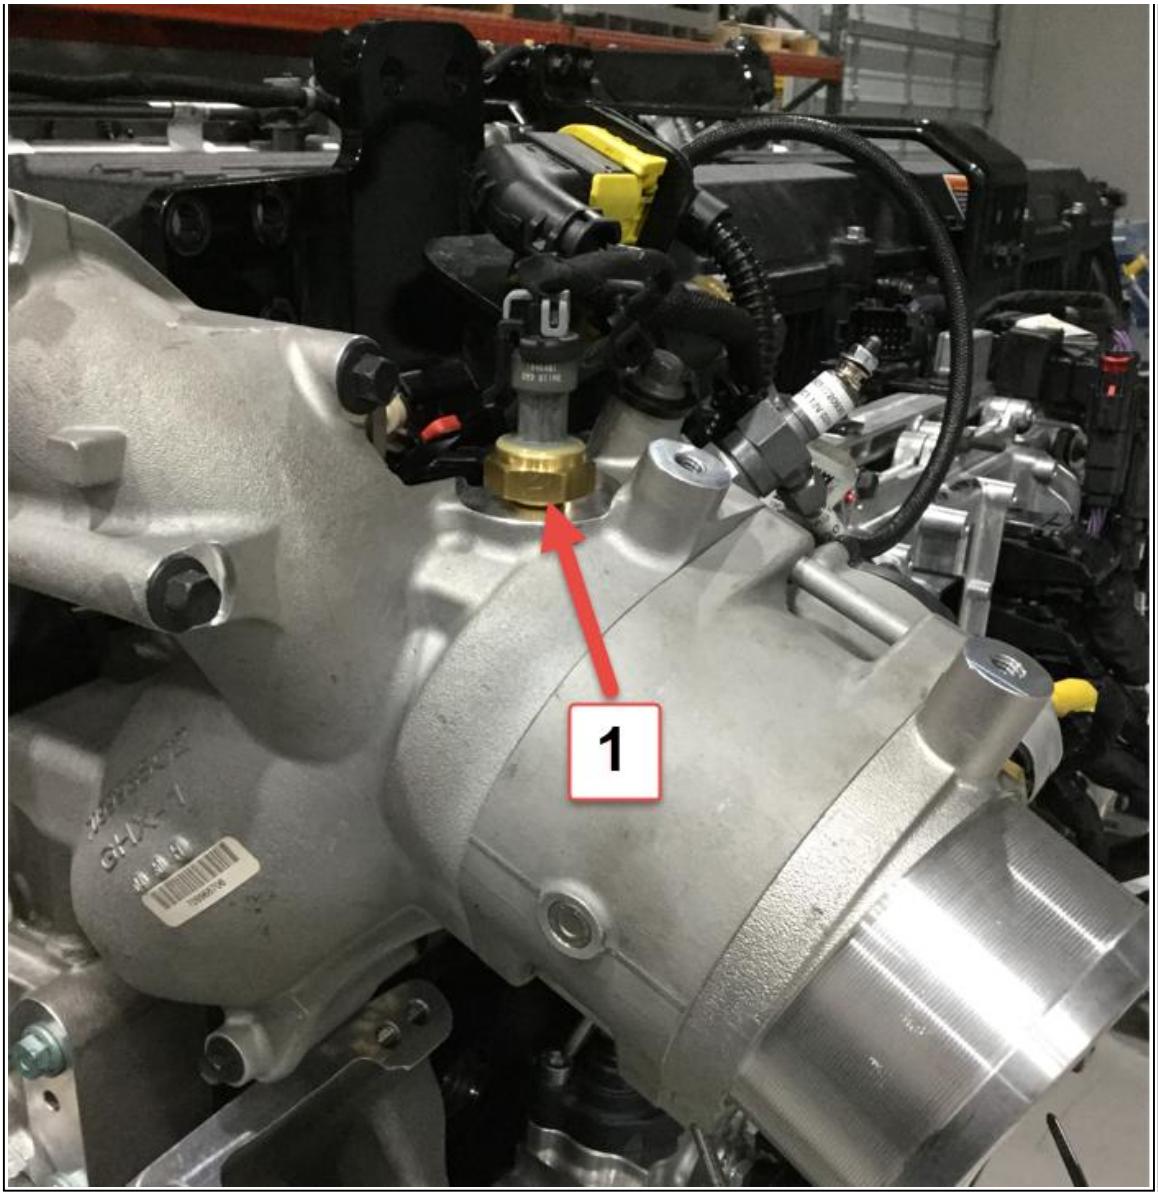
**Figure 1: Sensor Mounting Location**

This document will guide the user through diagnosing a 2021 A26 powered vehicle experiencing low power while being operated in cold climates. The intake manifold pressure (IMP) sensor has been relocated slightly on the 2021 A26 due to the addition of the ITV. In extreme cold conditions, moisture can collect in the sensor and freeze causing the sensor to not read accurately.

Item 1: Intake Manifold Pressure (IMP) Sensor

1.) Remove the intake manifold pressure (IMP) sensor (figures 1,2,3) and inspect for ice or condensation. If any ice or condensation is found, carefully dry out the sensor, then install and retest.

- If this does not correct the issue, proceed with sensor replacement and retest.

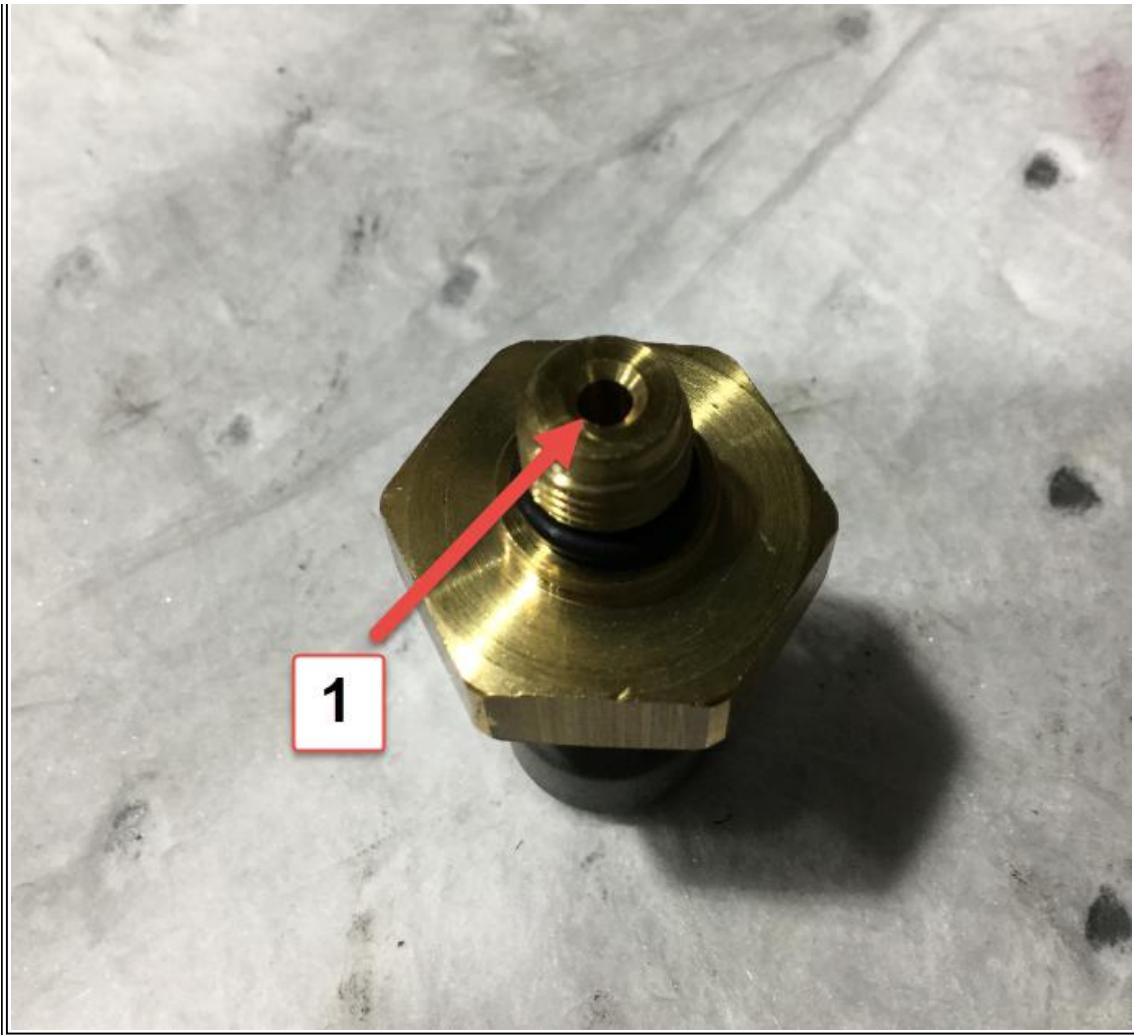
**Figure 3: Intake Manifold Pressure (IMP) Sensor**

Item 1: Intake Manifold Pressure (IMP) Sensor Orifice
