## Mack Chassis - Model TD Only Equipped With An MP10 Mack Engine - AHI Harness Failure Related Fault Codes P249F00, P20DD13, P113413

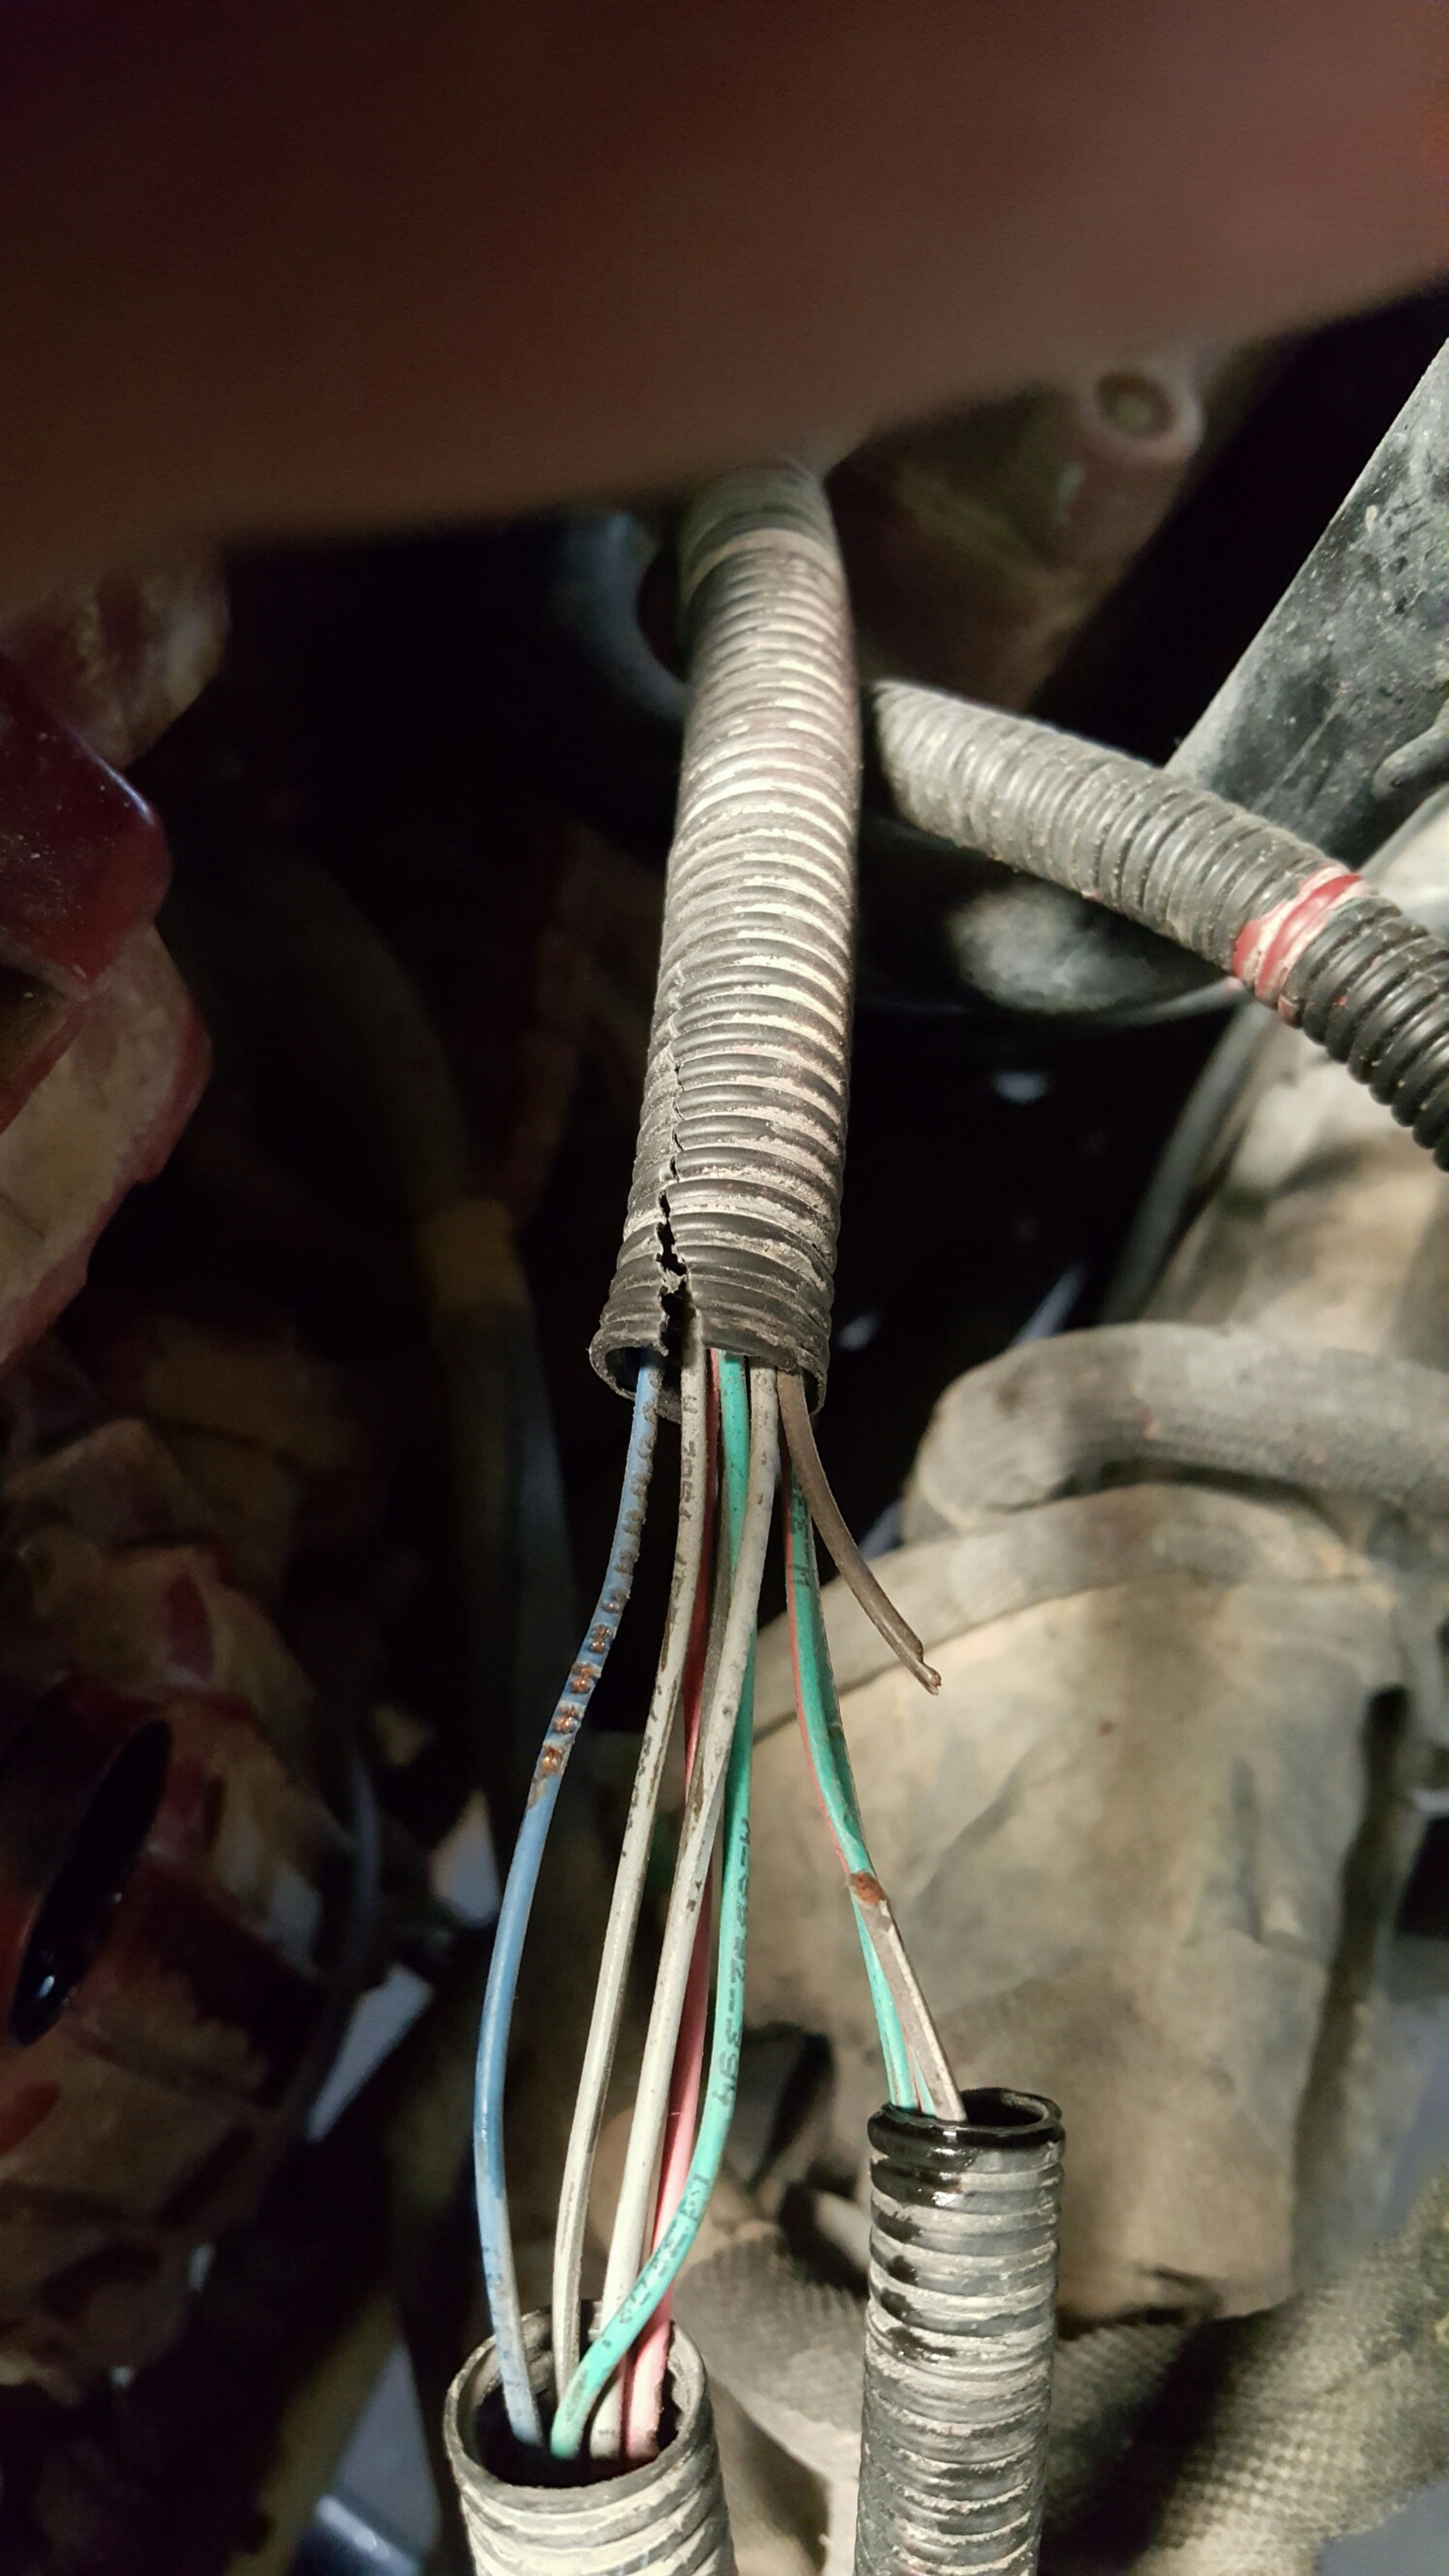
Once the AHI harness has been inspected and found to have failed internally, example as seen in the picture [here](#) , it will need to be replaced.
