SERVICE BULLETIN

**SB-21-011 CONVENTIONAL LANE DEPARTURE
WARNING (LDW) CAMERA HARNESS REPAIR**

**GROUP: 0-GENERAL
BULLETIN NO: SB-21-011
DATE: 12-13-2021
REF: HMM-211206-B1**

Subject: 2020-2021MY Conventional trucks equipped with the LDW system.

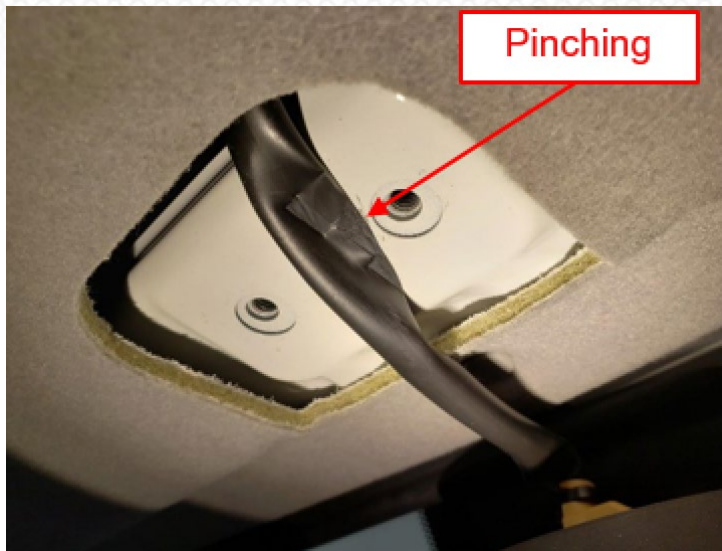
3. Thoroughly inspect the wire harness that connects to the LDW camera for pinching condition around the camera bracket. If a pinching condition is found, proceed to step 5 in the repair procedure. If no pinching of the LDW harness is found, a pinched LDW harness is not the likely cause of the condition. Continue with normal diagnosis using the troubleshooting manual to determine the root cause.

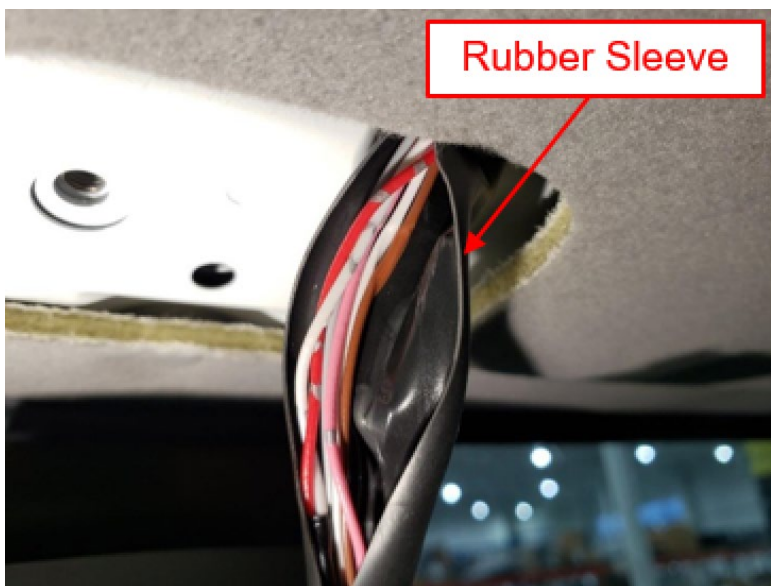
6. Cut open the rubber sleeve around the wiring to expose the pinched area of the LDW camera wire harness.

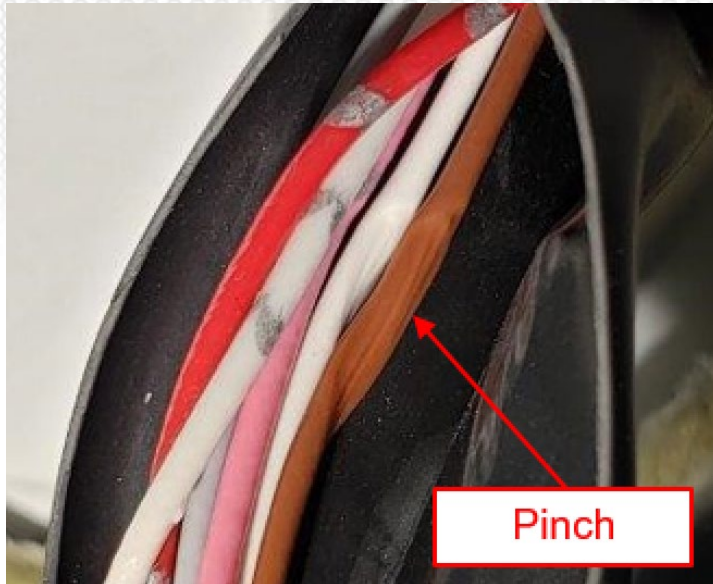
7. Inspect the wires for signs of damage. It may be possible that the pinch only affected the rubber sleeve. If only the sleeve was affected, proceed to step 12. If wires have been pinched, proceed to step 9.
