Functional impairment of 48 V on-board electrical system

Topic number	LI54.10-P-069698
Version	13
Function group	54.10 - Battery, power supply, voltage converter
Date	12/15/21
Validity	Model series 257, 213, 238, 167, 290 with code B01
Reason for change	updating Cause/Remedy 2

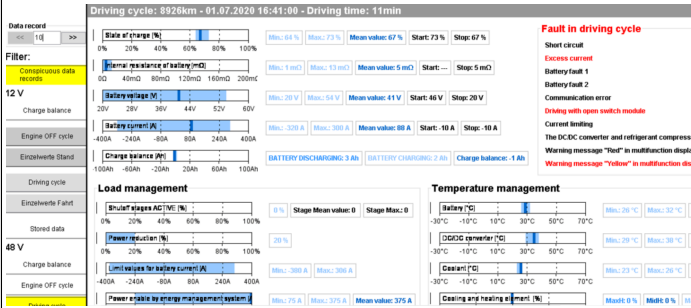
Attachments	
File	Description
Excess Current.png

1. In Xentry go to N10/6 FSAM, on-board electrical data, conspicuous data. Locate date/time of complaint.
2. Review Fault Driving Cycle to check if Excess current is or is not highlighted in Red. Then we have two different options below: step 3 below Excess Current highlighted in Red...OR... step 4 below excess current is NOT highlighted in Red (or if 2nd visit for this complaint).

3. First option: excess current IS highlighted in Red (OR if 2nd visit for this complaint) create a PTSS case with the following:

Excess current in N10/6 conspicuous data
