# E280 - EPA21 MX-11/MX-13 Oil Pan and Exhaust Manifold Incorrectly Torqued

E280

12/2/2021

Certain DC tools were incorrectly calibrated. The resulting torque issue could affect the EPA21 MX-11 and MX-13 Oil Pan and/or the Exhaust Manifold.

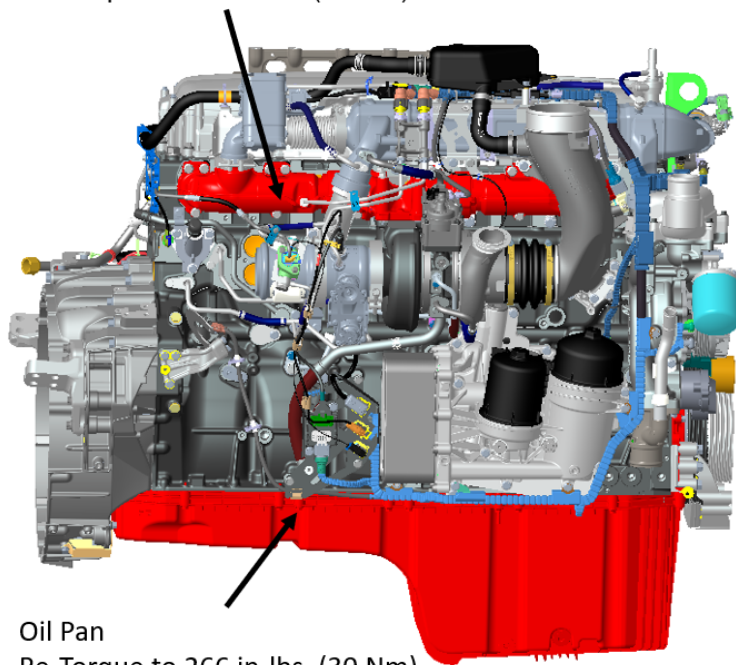
Exhaust Manifold  
Re-Torque to 531 in-lbs. (60 Nm)

Oil Pan  
Re-Torque to 266 in-lbs. (30 Nm)
