T012 - PACCAR TX-12 Main Drive Gear Premature Wear

Transmission - 26

PACCAR TX-12 Main Drive Gear Premature Wear

12/2/2021

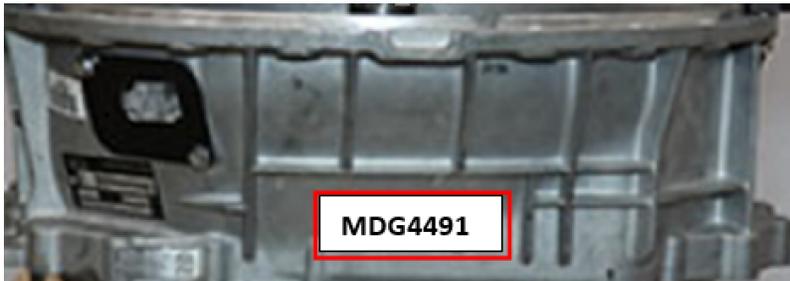
1. Check clutch housing for "MDG4491" marking, indicating a previous repair. If marked as repaired, no further action is required.
