# Volvo Chassis - FSB 381-022, Instrument Cluster, Reprogramming (MID 140)

## 38191-9 FSB 381-022, Instrument Cluster, Reprogramming (MID 140)

(September 2019)

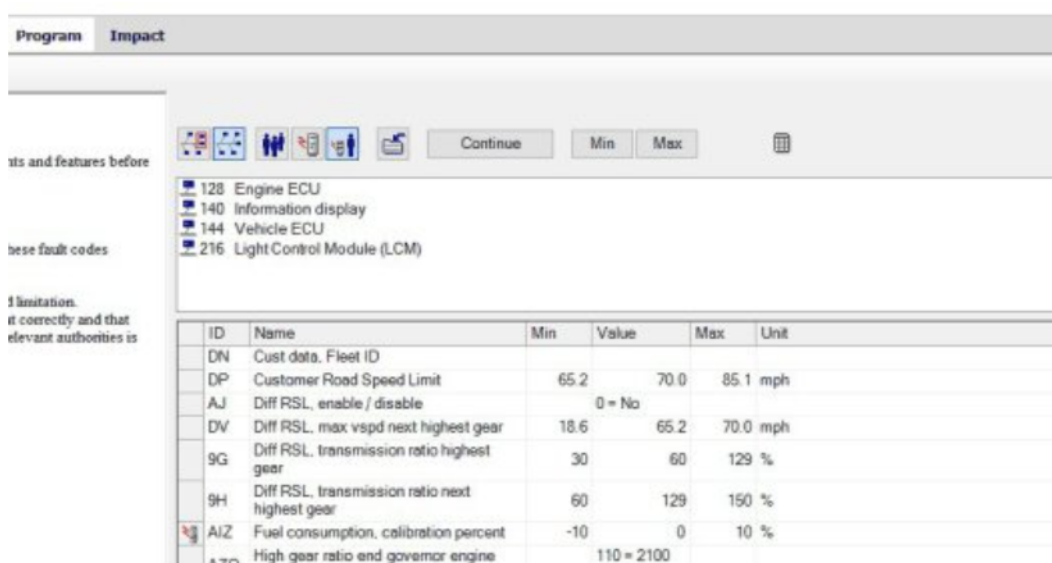
On certain Volvo models equipped with Cummins engine, after replacing the instrument cluster, the system pops-up an error (Fault Code SPN 639 FMI 9 Or SID 231 FMI 9). This is due to an incorrect set parameter in Premium Tech Tool (PTT). To correct this issue, follow the parameter programming steps outlined in this Field Service Bulletin.

14. Select 140 Information display.

15. Find parameter IBS and make sure it is enabled.

16. Click Continue once changes are made.
