## 13 Liter Engines ONLY - Engine Coolant Pump Housing Leak; Coolant Found Around The Oil Cooler Duct Cover Or In Between The Coolant Pump Housing And Oil Cooler Housing - Model Years 2019 And 2020

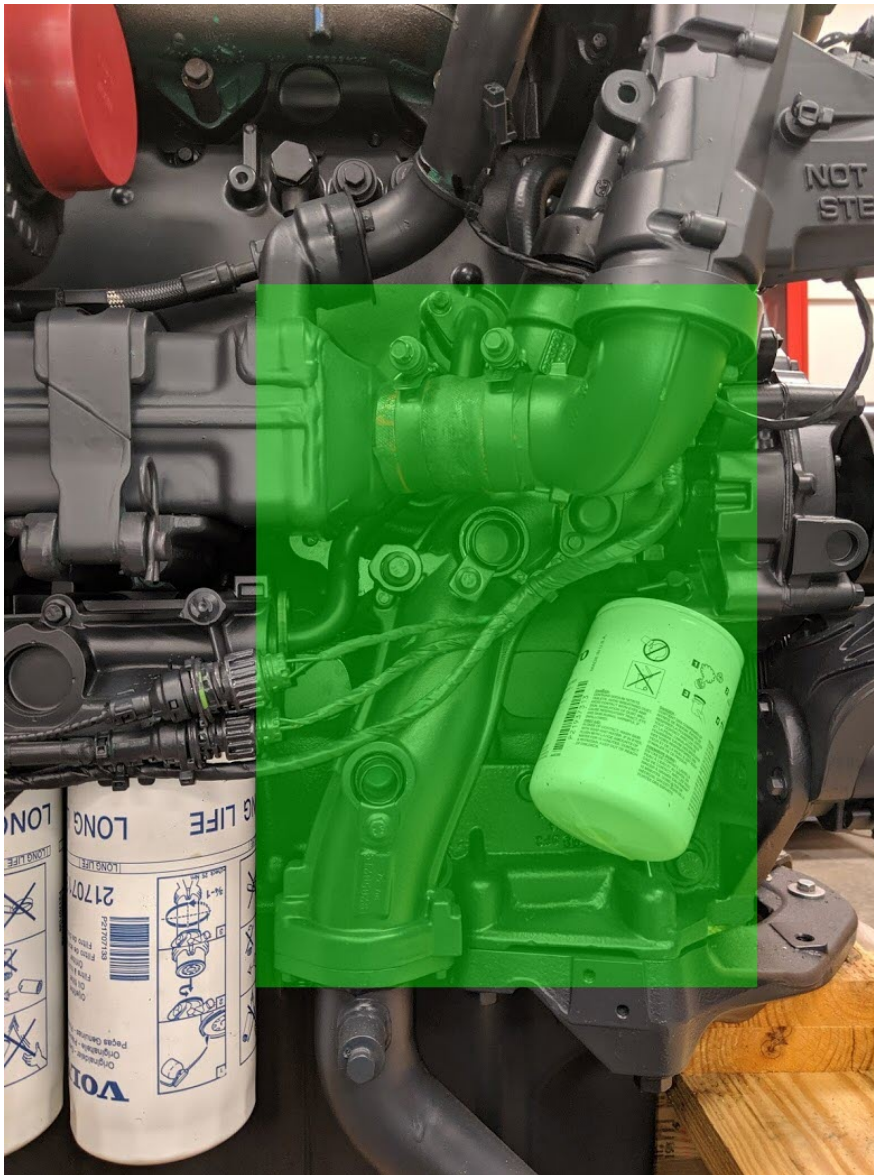
Vehicles affected by this issue will show coolant runoff on the front rights side of the engine. The likely area coolant will be found is highlighted below:

- Replace the coolant pump cover.
- Replace the seal between the oil cooler duct cover and the coolant pump.

**Note:** Ensure the seal is properly seated when reconnecting the housing and duct cover. If the seal is improperly seated, leakage may persist after repairs are complete.

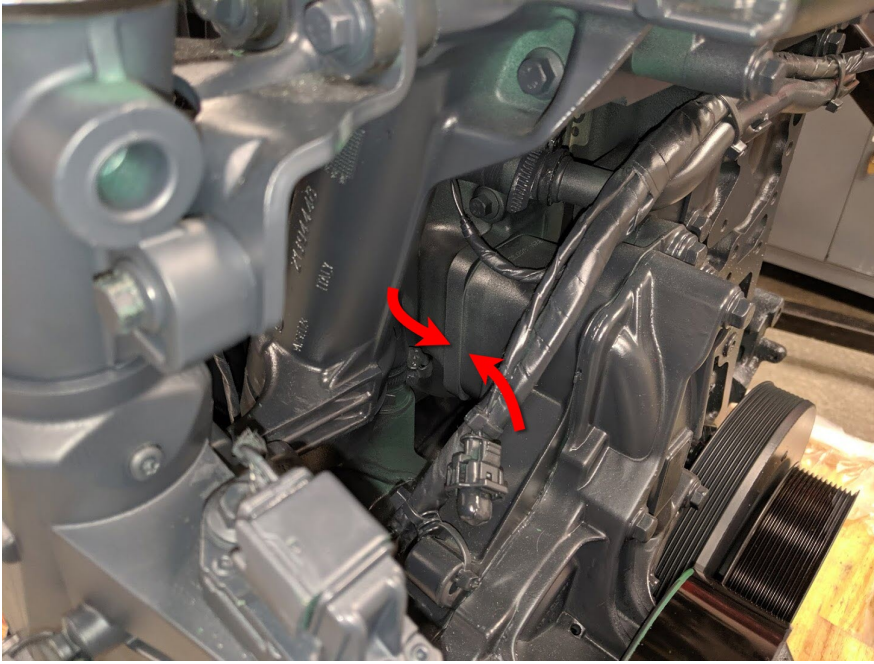
Live UI: The area in between the coolant pump housing and oil cooler duct cover should be checked:

**If a vehicle presents with a coolant leak in the area shown and the source of the leak is traced to the surfaces between the oil cooler duct cover and the coolant pump housing:**
