## Bendix Blindspotter - Side Object Detection System - Blind Spot Sensor False Warning Information

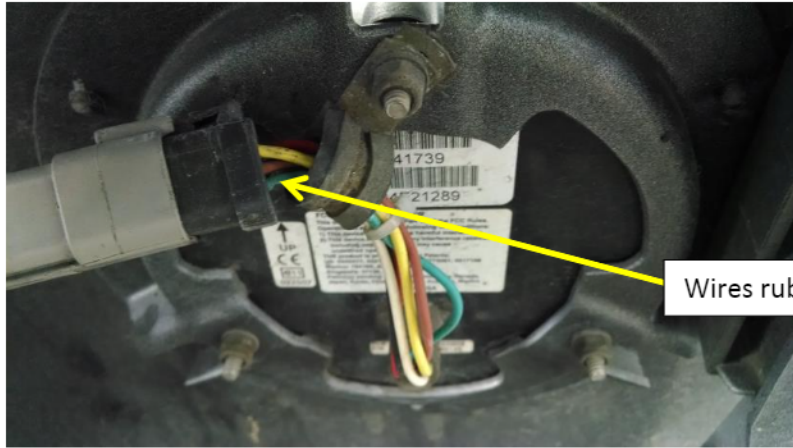
Reports show that after diagnosing the Bendix " BlindSpotter " - Side Object Detection System - the blind spot sensor circuit wiring may have been chaffed at the wire clamp locations shown [here](#).

Wires rubbed under the clamp
