## Technical product information

| <b>Topic</b> | Outer daytime running light/s not working - Warning message within the DIP |
| <b>Transaction No.</b> | 2055589/4 |

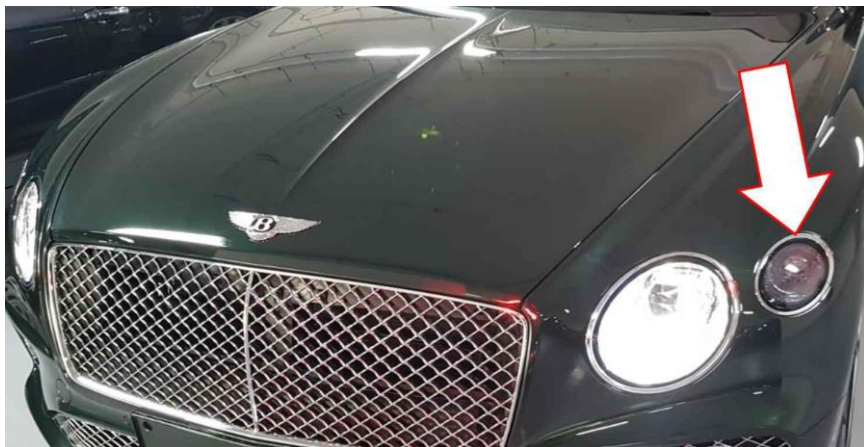
Figure 1

- Left and/or right outer daytime running light/s not working (Figure 1)

- DTC C10EF04 evident within Diagnostic address 29 Light control left and/or 39 Light control right

A software error in the headlight control modules can lead to malfunctions with the front Daytime Running Lights.

The software of address 29—*Light control left* and address 39—*Light control right* require reprogramming.

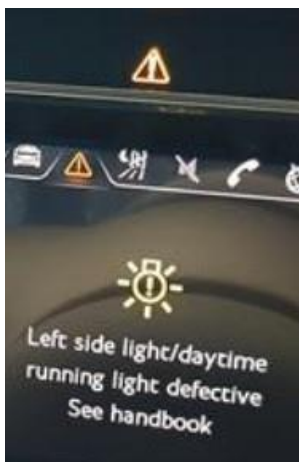
Figure 2

- Warning message also evident within the DIP (Figure 2)
