# Driver's Airbag Resistance Checks

| <b>Bulletin type:</b> | Service Campaign |
| <b>Campaign reference:</b> | 00 N 010 |
| <b>Affected vehicles:</b> | McLaren GT, McLaren Elva, McLaren Speedtail |

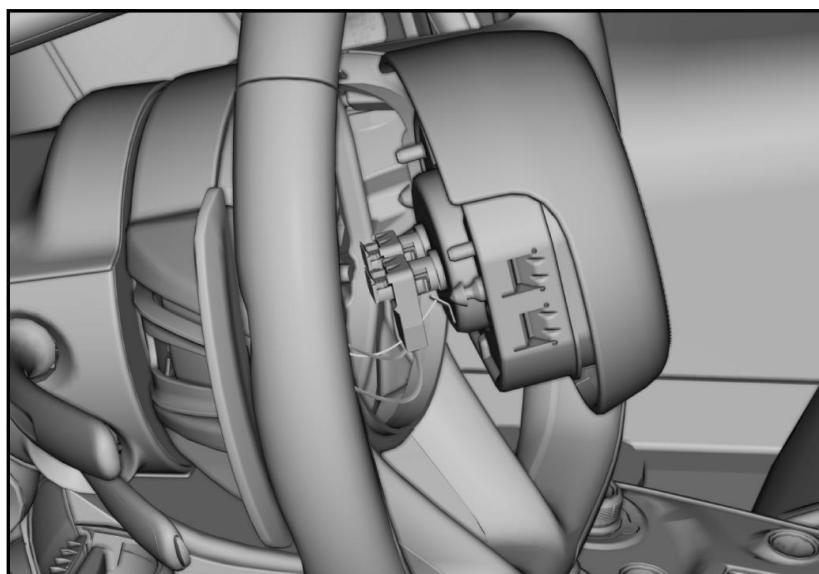
Image 1

If the driver's Airbag Resistance Values are found to be out of tolerance a physical check of the airbag connectors must be completed.

Driver Airbag Connectors (example taken from the Service Information System (SIS))

Disconnect the driver's airbag connectors and visually inspect them for any anomalies, then fully re-connect the connectors. Make sure both stages of the connectors are correctly locked and engaged. The connector may be installed, but not locked.

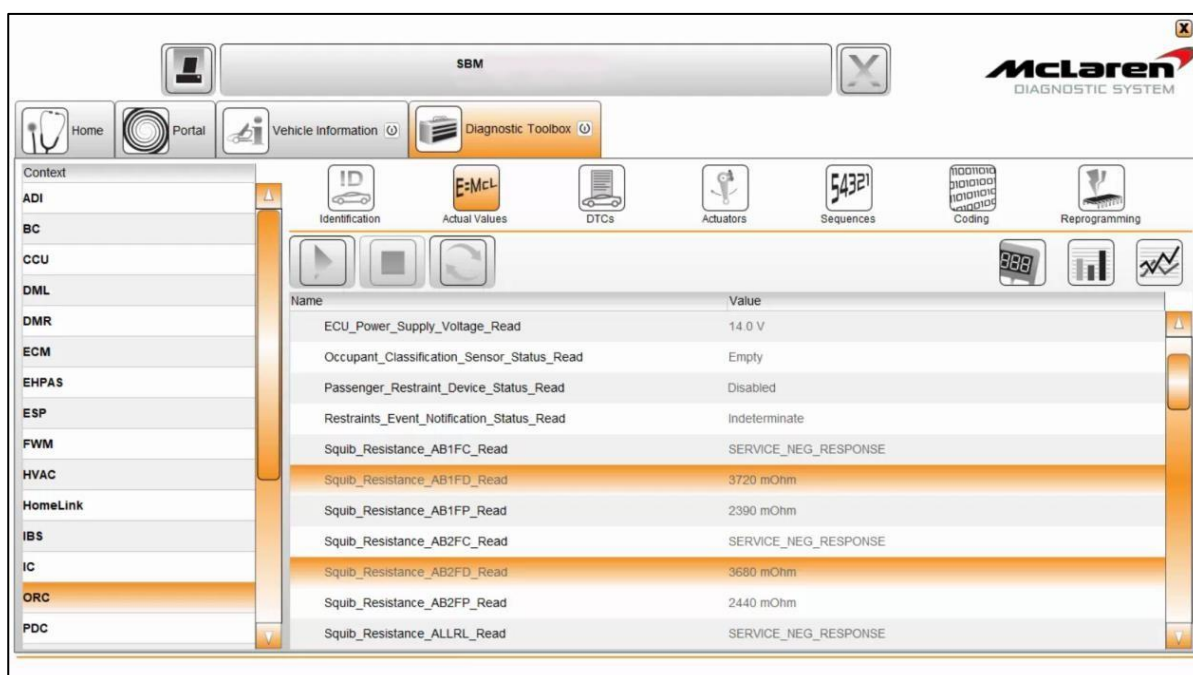
Image 2 - Example Screenshot of MDS Airbag Resistance Actual Value Location

Re-scan the vehicle with MDS and check the **AB1FD** and **AB2FD** Squib Resistance Actual Values again. The Squib Resistance Actual Values must now be within the correct resistance tolerance limits (**between 2100 mOhm and 5600 mOhm**) as stated in 'Table 1' above.
