TECHNICAL TOPICS

POWERTRAIN

Oil ingress in air intake system – AJ20-D4

MY 17-19 F-Pace , XF, XE , RR Velar

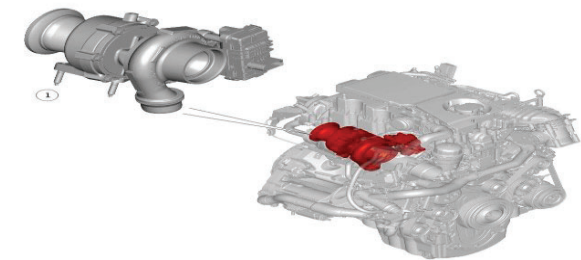
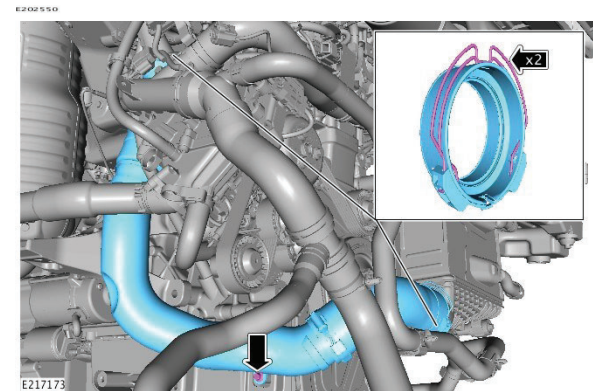
- Oil ingress is found in the intake system, (air-path pipes, manifold, intercooler and turbocharger)
- Usually after a turbo seal has failed.

- Check for leaks and blockages after Turbo replacement.
- Thoroughly inspect and remove air path pipes, intake manifold, and intercooler to clean before starting vehicle in the workshop to make sure all residual oil and debris are removed from air intake system
- Do not replace components due to oil ingress until proven defective.
