# McLAREN ELVA– FACIA BLOCK FIXING REWORK

| <b>Campaign reference:</b> | SCB 26 N 001 |
| <b>Situation:</b> | Potential bolt relaxation on retention fixings of upper and lower facia block assembly |

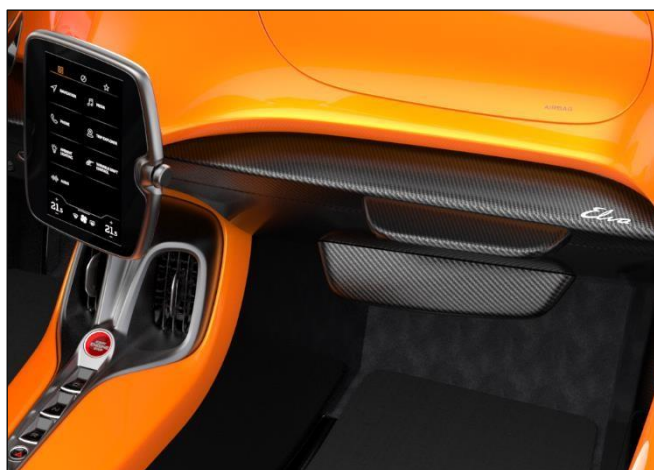
Through continuous product quality monitoring, McLaren Automotive has identified a bolt torque relaxation condition that could affect the upper and lower facia block retention fixings in some McLaren Elva vehicles. A potential relaxation of those fixings may have an adverse effect on panel gap which can influence the knee airbag deployment profile. Therefore, a facia block fixing rework procedure has been released for all affected vehicles.

View of the upper and lower passenger facia blocks

To perform the facia block fixing rework, Document SCB 26 N 001 WI has been attached with this Bulletin. This Document contains the relevant work instructions and care points to ensure the required work is carried out to bring the vehicle up to the latest manufacturing standard.
