SERVICE BULLETIN

Classification: EL21-012	Reference: NTB21-077	Date: November 22, 2021
-----------------------------	-------------------------	----------------------------

DRIVERS POWER SEAT IS INOPERATIVE

APPLIED VEHICLES: 2013-2018 Altima (L33)
2015-2021 Murano (Z52)

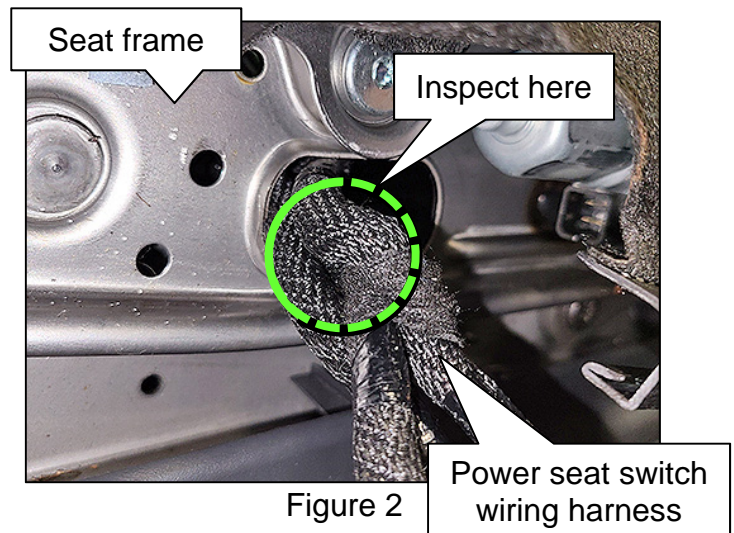
Figure 2

2. Inspect the entire outside circumference of the power seat switch wiring harness, where it passes through the seat frame, for spots that have been worn through.

HINT: The hidden side of the seat harness is represented by dotted line in Figure 2.

- If any wires are found damaged, proceed to step 3.
- If no wires are found damaged, skip to step 4 on page 3.
