QUALITY ACTION

CAMPAIGN BULLETIN

Main Harness Routing Dealer Inventory

Reference: PC852

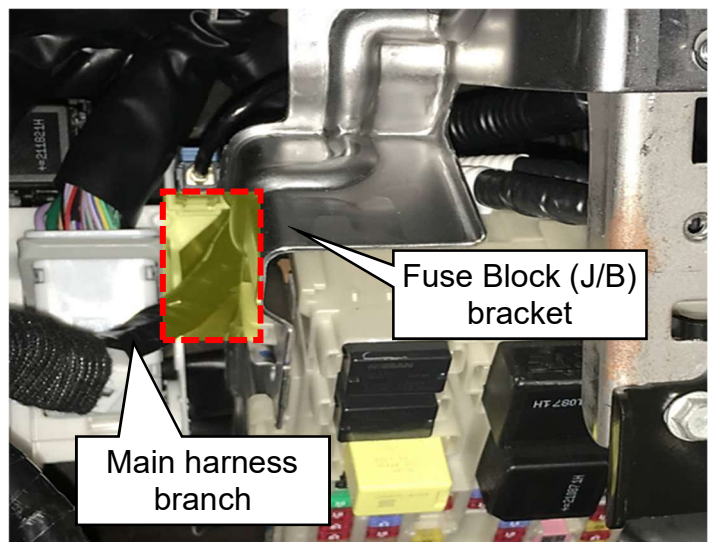
8. Inspect the harness branch shown in Figure 8 for cut (separated) or exposed wires (missing wire insulation, bare wire visible).

Abrasion or damage to the tape of the main harness is OK.

- If there are no cut or exposed wires, continue to **Step 9**.
- If the harness branch has any cut or exposed wires, contact FQA using the information contained in **Step 16** and do not perform any further repairs until a response is received.

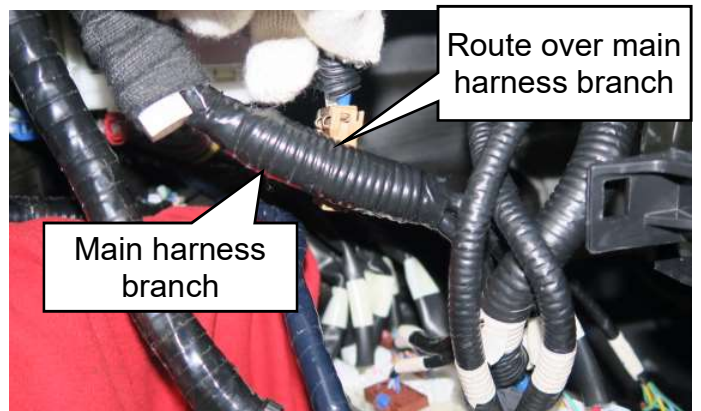
Nissan is conducting a dealer inventory quality action to inspect the main wiring harness, install a section of wiring conduit and reroute the harness on 2,059 specific MY2022 Nissan Pathfinder vehicles identified in Service Comm and National Service History – Open Campaigns. During manufacturing, the main wiring harness may have been misrouted at the fuse box connection causing contact with the fuse box.

14. Reposition the harness branch.

- Disconnect the brown harness connector from the fuse block. (Figure 15)
- Route the harness over and behind the harness branch as shown in Figure 16
- Reconnect the brown harness connector and pull upward on the harness connector to verify the connector is fully seated in the fuse block (J/B) (Figure 17)
