Technical product information

Topic	Infotainment screen stalls at Initialising
Market area	Bentley: worldwide (2WBE)
Brand	Bentley
Transaction No.	2061536/4
Level	EH
Status	Approval
Release date

New Continental GT - GTC and New Flying Spur

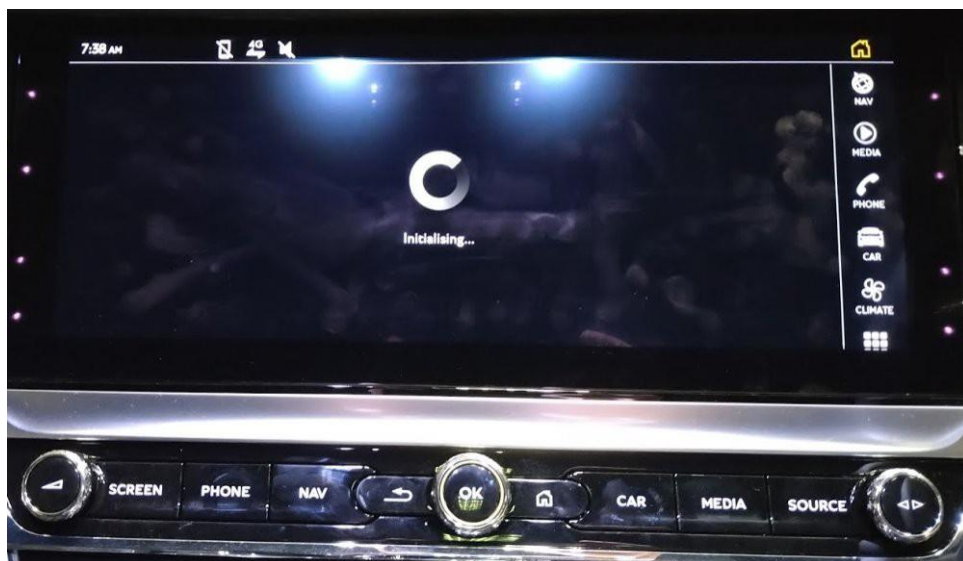
Figure 1

Upon start-up of the Infotainment system, the home screen appears to be stuck in the "Initialising" stage, when this scenario is evident a spinning wheel is visible (Figure 1)

The issue occurs when the Infotainment system is shut down with the "Home" menu screen displayed. The Infotainment will start up on this screen the next time the vehicle is started
